**MINI CABRIO: EY8484**

**Limited Technical Inspection**

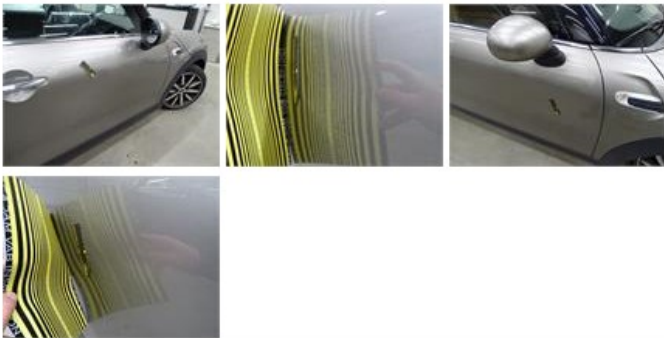
Door F R, Dent(s), PDR - Paintless dent repair 82,80
