PEUGEOT 308: 1JAL573

Limited Technical Inspection

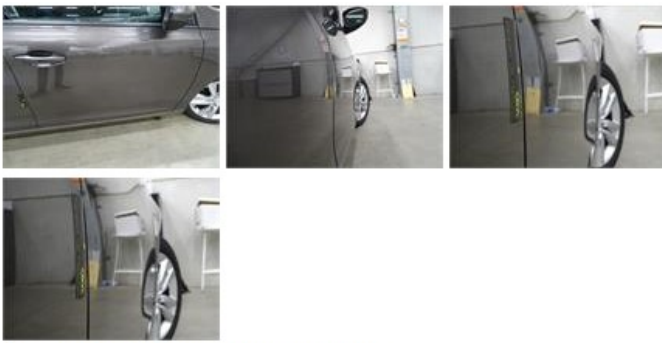
Total cost ex VAT	190,00
Door F R, Dent(s), Acceptable	0,00

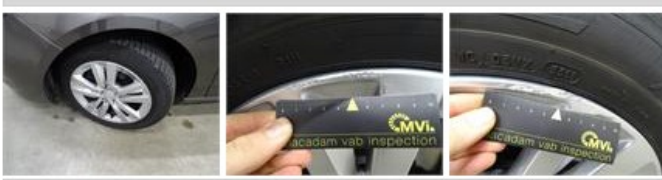
Alloy rim F L, Scratch(es), LI - Repair and paint (complete) 95,00

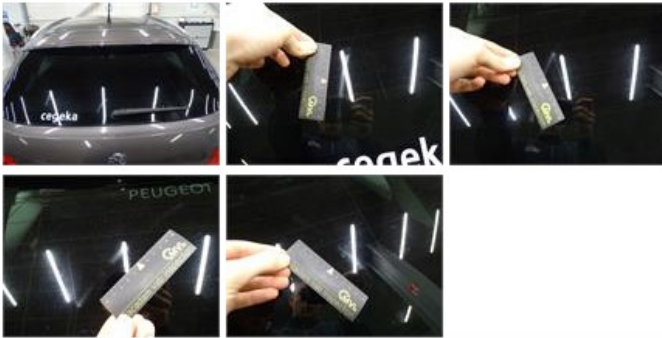
Rear window, Scratch(es), Acceptable 0,00

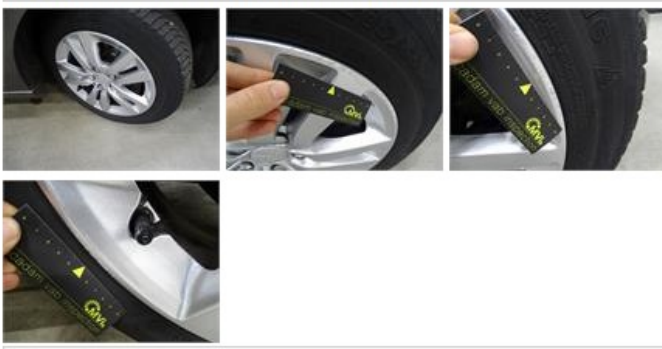
Alloy rim F R, Scratch(es), LI - Repair and paint (complete) 95,00
