OPEL INSIGNIA SPORTS TOURER: 1KXC109

Limited Technical Inspection

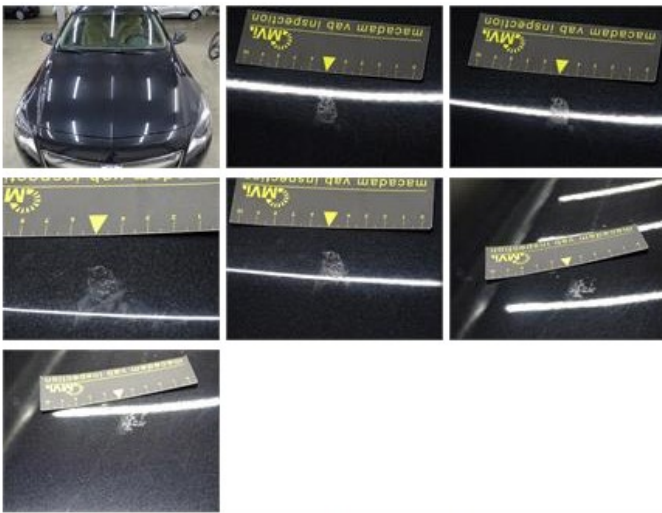
Total cost ex VAT	1182,58
Wing F L, Scratch(es), Acceptable	0,00
<i>No pictures to display</i>	
Bonnet, Chemical polution, LI - Repair and paint (complete)	290,08

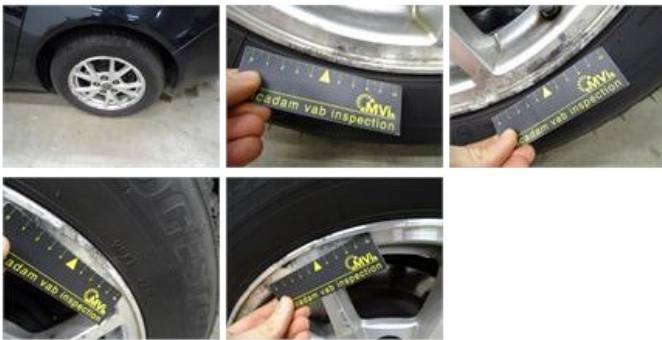
Alloy rim R L polished, Scratch(es), LI - Repair and paint (complete) 95,00

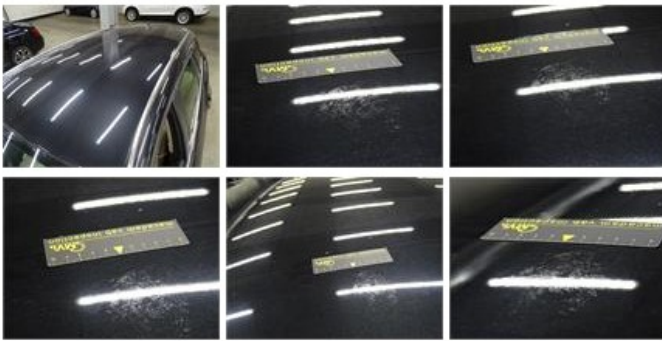
Roof, Chemical polution, LI - Repair and paint (complete) 481,50

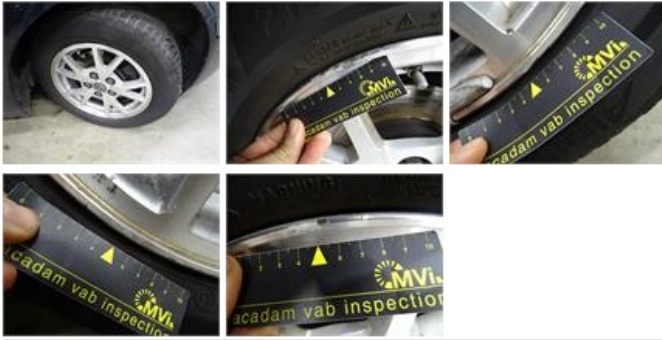
Alloy rim F R polished, Scratch(es), LI - Repair and paint (complete) 95,00
