**SKODA Superb: 1HPH008**

**Limited Technical Inspection**

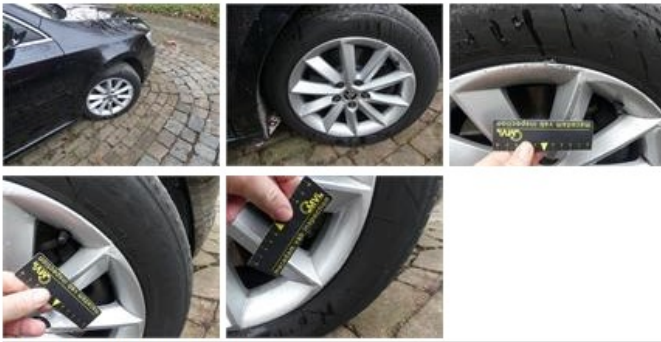
Alloy rim F R, Scratch(es), LI - Repair and paint (complete)

95,00

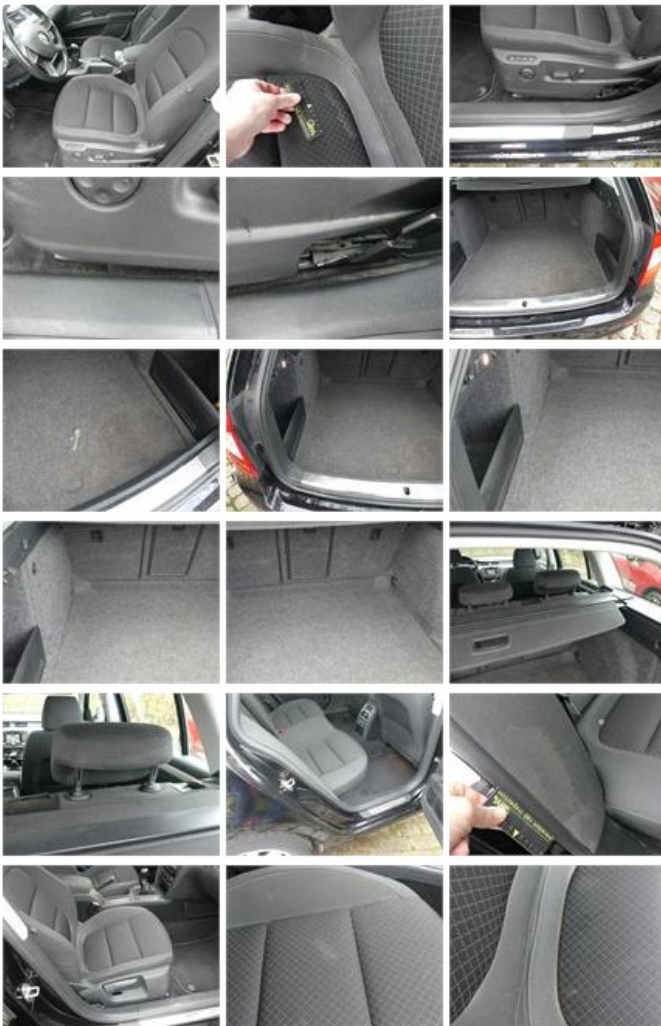
Interior, Dirty, Cleaning

75,00

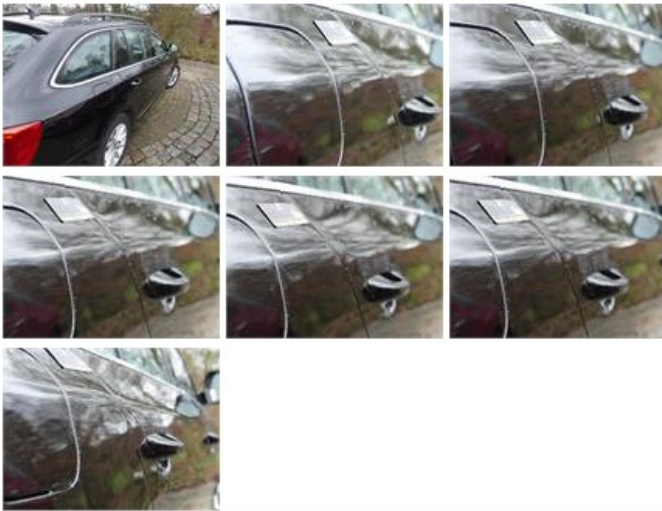
Wing R R, Bad repair, P - Check

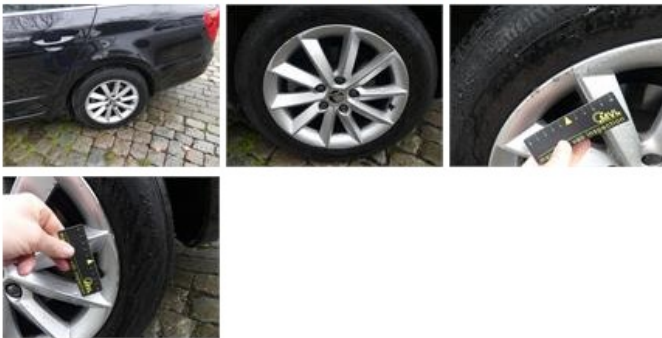
Trunk lid covering R, Scratch(es), Acceptable	0,00
<i>No pictures to display</i>	
Alloy rim R L, Scratch(es), LI - Repair and paint (complete)	95,00

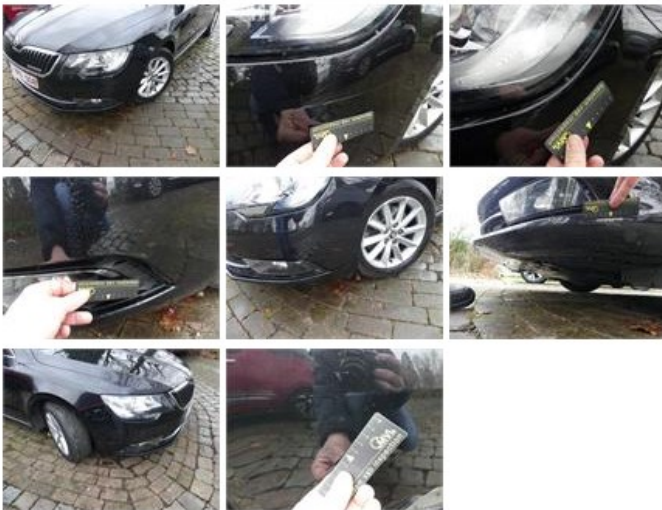
Rearview mirror housing R, Scratch(es), Acceptable	0,00
<i>No pictures to display</i>	
Door F L, Scratch(es), Acceptable	0,00
<i>No pictures to display</i>	
Bumper F, Scratch(es), LI - Repair and paint (complete)	254,16
