**VOLKSWAGEN TOURAN: 1LSJ472**

**Limited Technical Inspection**

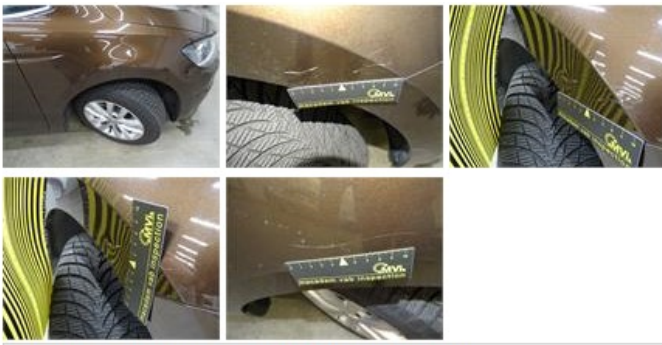
Total cost ex VAT	<b>1779,68</b>
Wing F R, Dent(s) and scratch(es), LI - Repair and paint (complete)	<b>220,18</b>

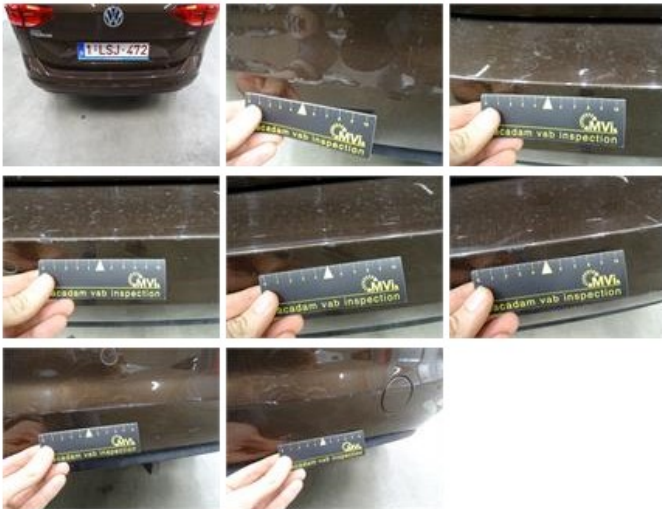
Bumper R, Scratch(es), LI - Repair and paint (complete) 211,80

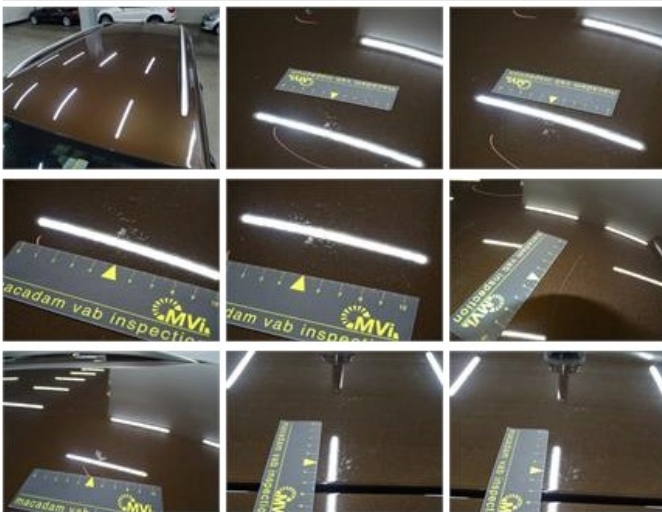
Roof, Chemical pollution, LI - Repair and paint (complete) 481,50

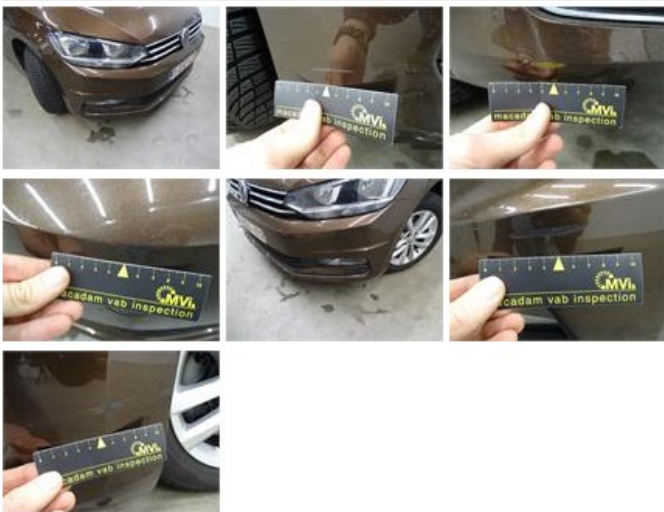
Bumper F, Scratch(es), LI - Repair and paint (complete) 211,80
