<b>VOLVO XC60: 1NAG952</b>			
Vinnumber:	<b>VV1DZARC1G2882509</b>	Versionname:	<b>2.0 D3 2WD SUMMUM</b>
First Registrationdate:	<b>4/01/2016</b>	Fiscalpower:	
Expertise Mileage:	<b>108349</b>	Power Kw:	<b>110</b>
Bodytype:	<b>SUV</b>	Body color:	<b>Gold</b>
Gearbox:	<b>MAN 6 VIT</b>	Paint type:	<b>Metalic</b>
Transmission:	<b>Front</b>	Rims summer:	<b>Aluminium</b>
Fueltype:	<b>Diesel</b>	Oil level:	<b>OK</b>
Battery functioning:	<b>Yes</b>	Parking lot:	<b>EX POOL</b>
Number of doors:	<b>5</b>		
Number of seats:	<b>5</b>		
Number head rests:	<b>5</b>		
Rims summer:	<b>Aluminium</b>		
Category:	<b>Passenger Car</b>		
Oil level:	<b>OK</b>		
Registration Certificate Car (BE):	<b>Yes</b>

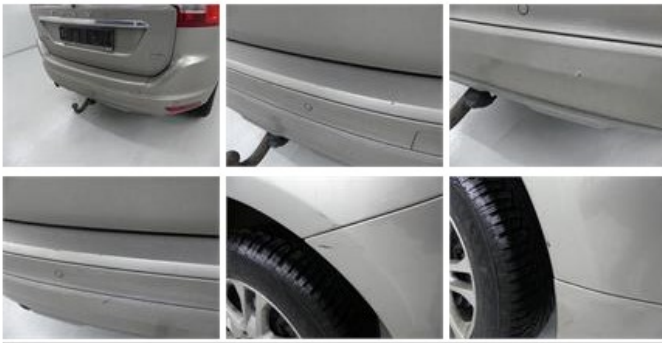
<b>Assistance equipment</b>			
Repair kit	<b>Yes</b>	Compressor	<b>Yes</b>
Total cost ex VAT			<b>349,16</b>
Rocker panel inner R L, Dent(s), Acceptable			<b>0,00</b>
<i>No pictures to display</i>			
Bumper Trim F, Scratch(es), Acceptable			<b>0,00</b>
<i>No pictures to display</i>			
Bumper R, Scratch(es), LI - Repair and paint (complete)			<b>254,16</b>
