## VOLKSWAGEN Passat: 1GG004

## Limited Technical Inspection

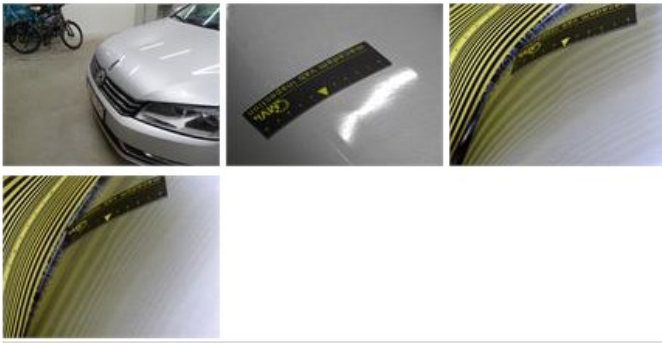
Total cost ex VAT	544,50
Tailgate, Scratch(es), Acceptable	0,00
<i>No pictures to display</i>	
Bonnet, Dent(s), PDR - Paintless dent repair	63,00
