VOLKSWAGEN TRANSPORTER: 1NDX075

Limited Technical Inspection

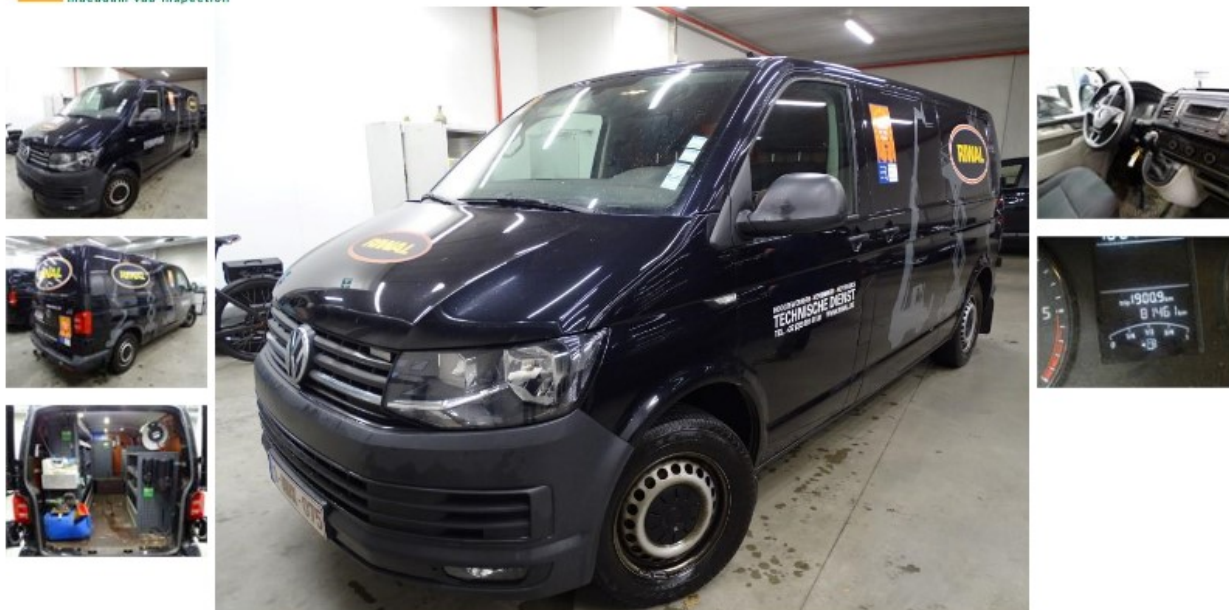
Vinnumber:	WV1ZZZ7HZGH036870	Versionname:	2.0CRTDI 103KW MSQ 2.8T LWB
First Registrationdate:	1/02/2016	Fiscalpower:	
Expertise Mileage:	81461	Power Kw:	103
Bodytype:		Body color:	Black
Gearbox:	Automatic	Paint type:	Opaque
Transmission:	Front	Rims summer:	Aluminium
Fueltype:	Diesel	Oil level:	OK
Battery functioning:	Yes	Parking lot:	2502
Number of doors:	6		
Number of seats:	2		
Number head rests:	2		
Rims summer:	Aluminium		
Category:	Light Commercial Vehicle		
Oil level:	OK		
Registration Certificate Car (BE):	Yes
