AUDI A5 SPORTBACK: 1LGK142

Limited Technical Inspection

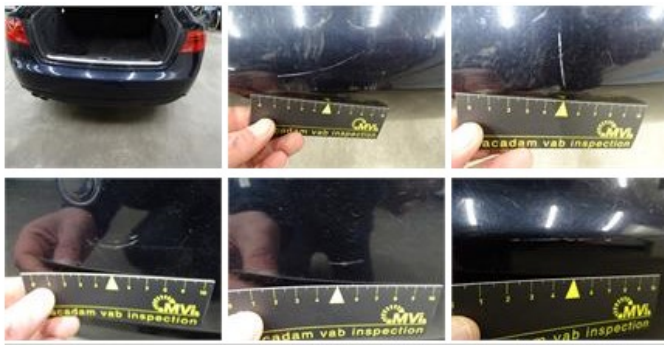
Total cost ex VAT	1541,13
Bonnet, Stone chip(s), Acceptable	0,00
<i>No pictures to display</i>	
Bumper R, Scratch(es), LI - Repair and paint (complete)	211,80

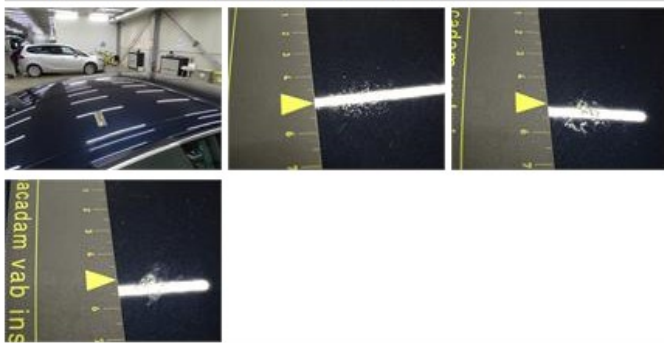
Roof, Chemical polution, LI - Repair and paint (complete) 481,50
