**BMW 5 TOURING: 1LCY660**

**Limited Technical Inspection**

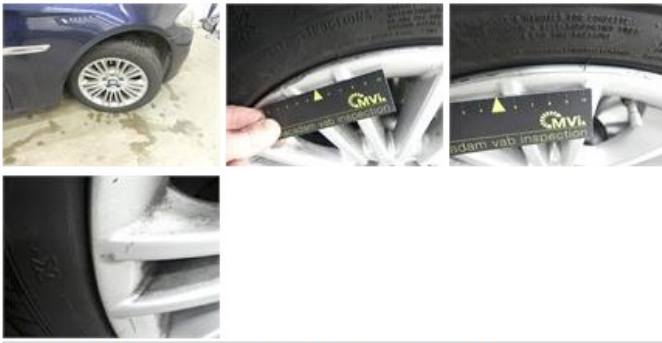
Total cost ex VAT	<b>539,16</b>
Alloy rim F R, Scratch(es), LI - Repair and paint (complete)	<b>95,00</b>

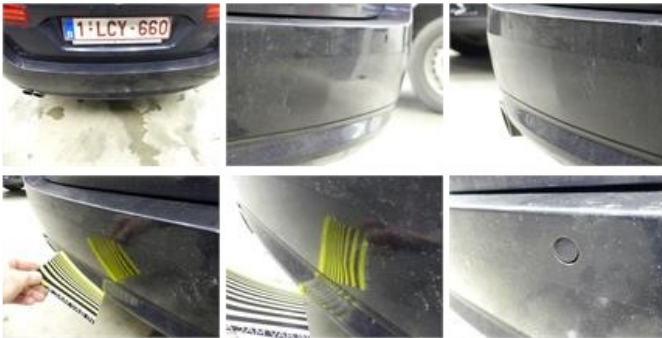
Bumper R, Dent(s), LI - Repair and paint (complete) 254,16
