Ford Transit: 1DLF436			
Vinnumber:	WF05XXBDF5CA33949	Versionname:	
First Registrationdate:	14/06/2012	Fiscalpower:	
Expertise Mileage:	91921	Power Kw:	74
Bodytype:		Body color:	White
Gearbox:	MAN 6 VIT	Paint type:	Opaque
Transmission:	Front	Rims summer:	Steel
Fueltype:	Diesel	Oil level:	OK
Battery functioning:	Yes	Parking lot:	LCV13
Number of doors:	5		
Number of seats:	3		
Number head rests:	3		
Rims summer:	Steel		
Category:	Light Commercial Vehicle		
Oil level:	OK

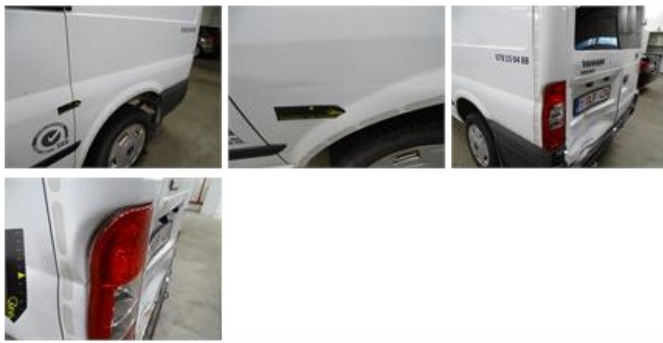
Wheel cover F L, Scratch(es), Acceptable		0,00
<i>No pictures to display</i>		
Wing R L, Dent(s) and scratch(es), LI - Repair and paint (complete)		303,15
