SKODA SUPERB COMBI: 1JJG076

Limited Technical Inspection

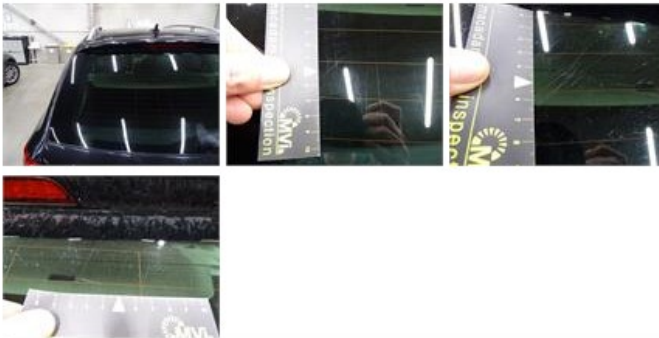
Rear window, Scratch(es), E - Replace
