VOLVO V40: 1LVE154

Limited Technical Inspection

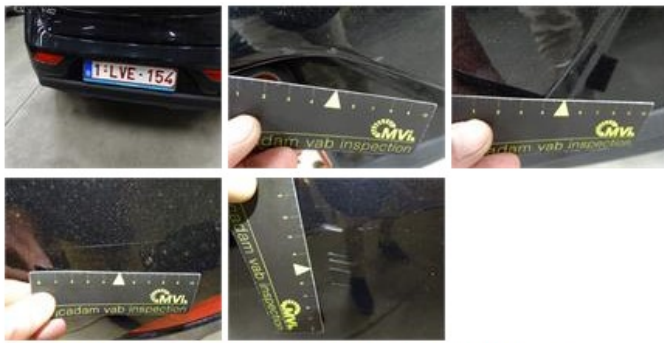
Total cost ex VAT	2465,67
Bumper R, Scratch(es), LI - Repair and paint (complete)	211,80
