**BMW 2 ACTIVE TOURER: 1LRA931**

**Limited Technical Inspection**

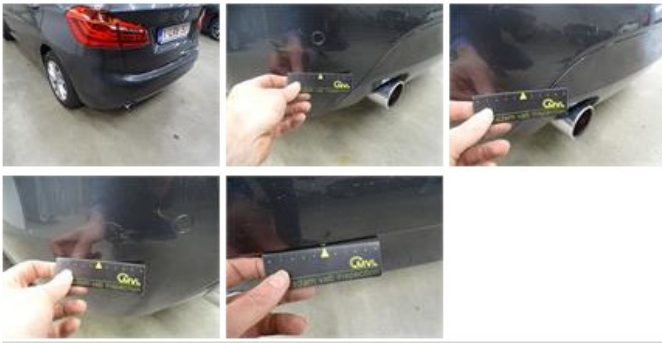
Bumper R, Scratch(es), LI - Repair and paint (complete)

211,80
