BMW 3: 1HUA554			
Vinnumber:	WBA3K91030F936375	Versionname:	3 TOURING 316d 116PK
First Registrationdate:	2/10/2014	Fiscalpower:	
Expertise Mileage:	118499	Power Kw:	85
Bodytype:		Body color:	Grey
Gearbox:	MAN 6 VIT	Paint type:	Metalic
Transmission:	Back	Rims summer:	Aluminium
Fueltype:	Diesel	Oil level:	OK
Battery functioning:	Yes	Parking lot:	4509
Number of doors:	5		
Number of seats:	5		
Number head rests:	5		
Rims summer:	Aluminium		
Category:	Passenger Car		
Oil level:	OK		
Registration Certificate Car (BE):	Yes

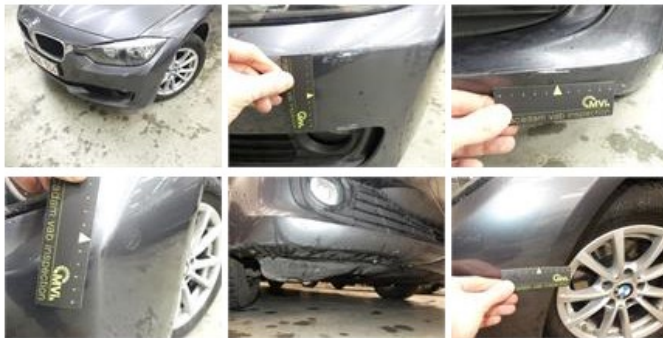
Bumper F, Scratch(es), LI - Repair and paint (complete) 211,80
