**BMW X2: 1UQX588**

**Limited Technical Inspection**

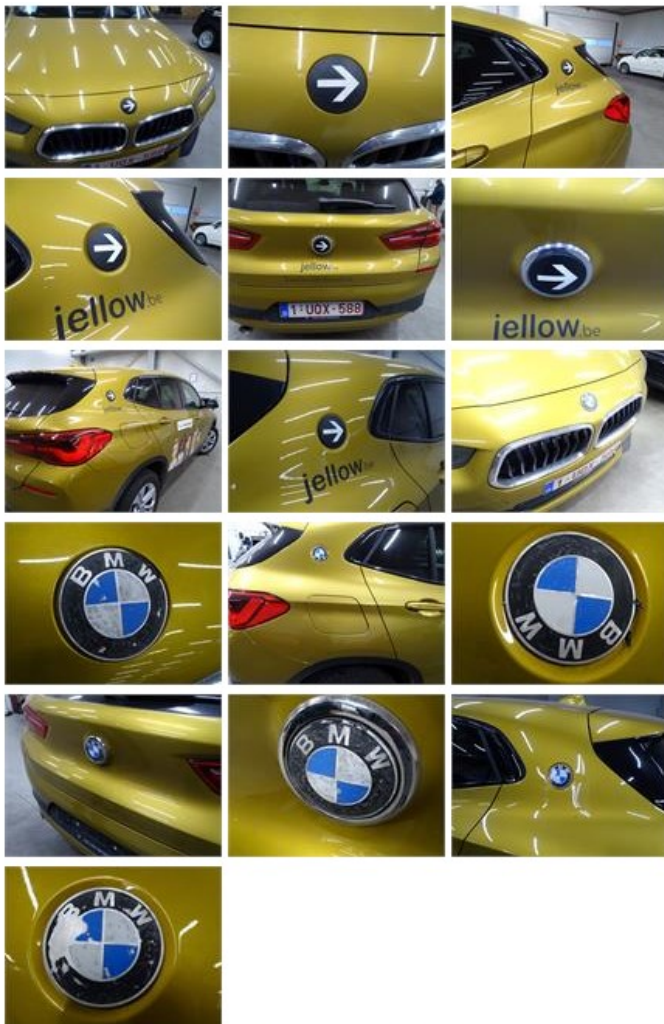
Model badge R, Not original part, Acceptable 0,00
