SKODA SUPERB COMBI: 1LSV716

Limited Technical Inspection

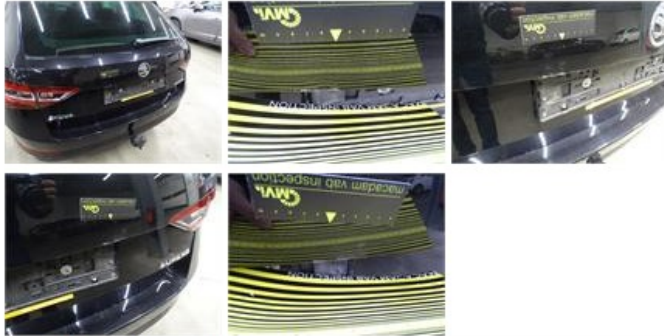
Tailgate, Dent(s) and scratch(es), LI - Repair and paint (complete)

362,02

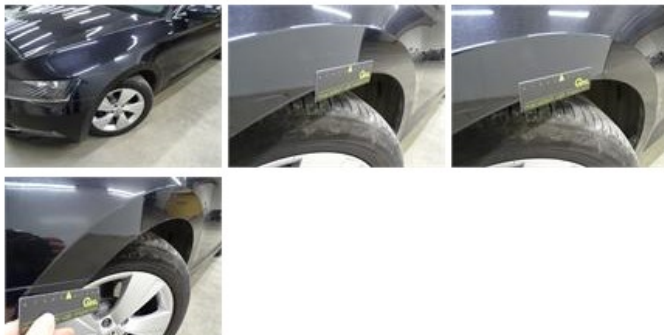
Wing F L, Scratch(es), LI - Repair and paint (complete)

264,21

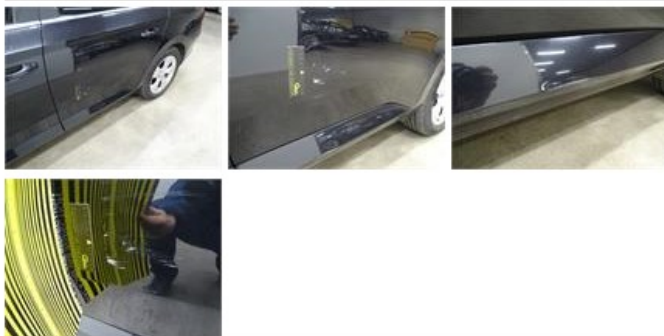
Door R L, Dent(s) and scratch(es), LI - Repair and paint (complete)

382,02
