VOLVO V60 CROSS COUNTRY: 1LSN383

| Vinnumber: | VV1FZARCDG1012691 | Versionname: | 2.0 D3 GEARTRONIC SUMMUM |

Limited Technical Inspection

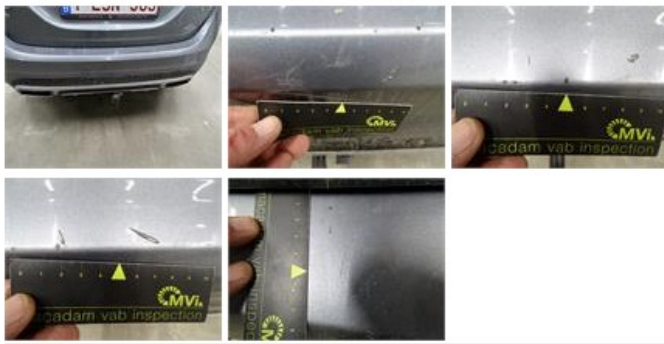
| Bumper R, Scratch(es), LI - Repair and paint (complete) | 211,80 |
