**VOLKSWAGEN Golf: 1JAP442**

**Limited Technical Inspection**

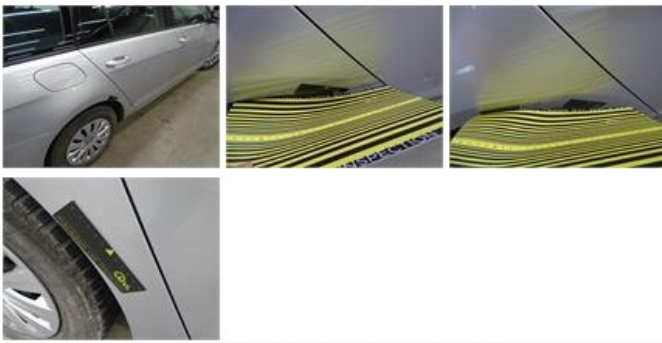
<b>Total cost ex VAT</b>	<b>3117,99</b>
<b>Wing R R, Dent(s), LI - Repair and paint (complete)</b>	<b>308,20</b>

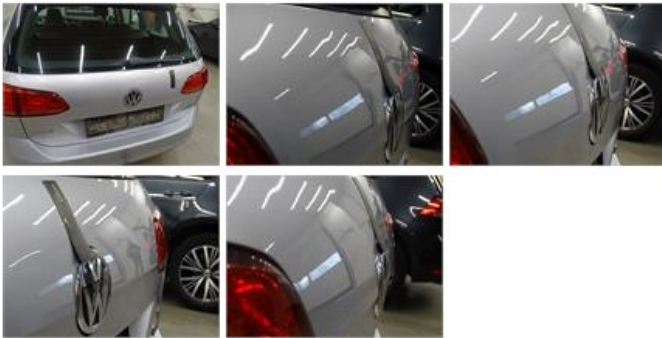
Tailgate, Dent(s), LI - Repair and paint (complete) 301,68

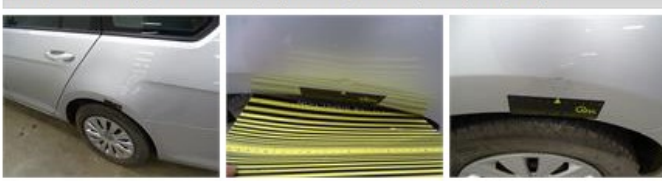
No pictures to display  
Wing R L, Dent(s) and scratch(es), LI - Repair and paint (complete) 308,20

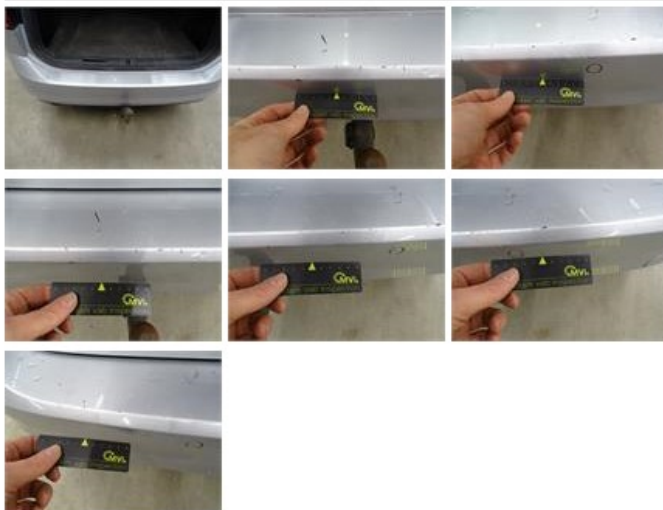
Bumper R, Scratch(es), LI - Repair and paint (complete)

211,80
