**RENAULT ESPACE: 1LUU864**

**Limited Technical Inspection**

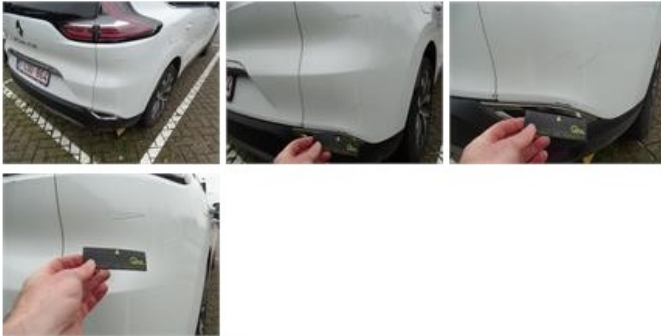
Bumper corner R R, Scratch(es), It - Spot repair

115,56

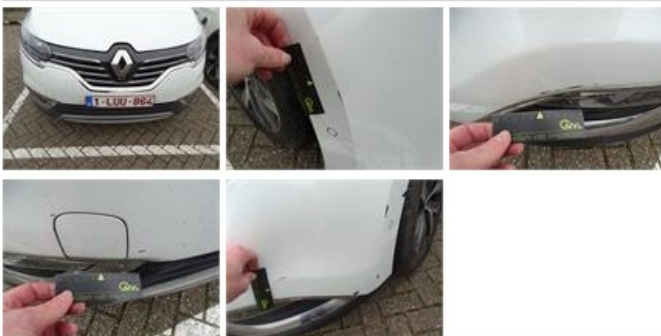
Bumper F, Scratch(es), LI - Repair and paint (complete)

254,16
