PEUGEOT 508 SW: 1KPC864

Limited Technical Inspection

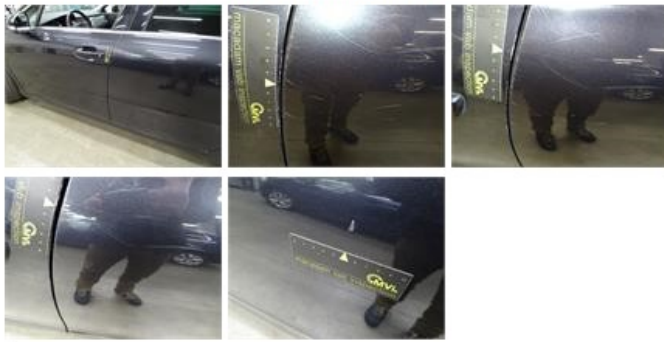
Door R L, Scratch(es), LI - Repair and paint (complete)

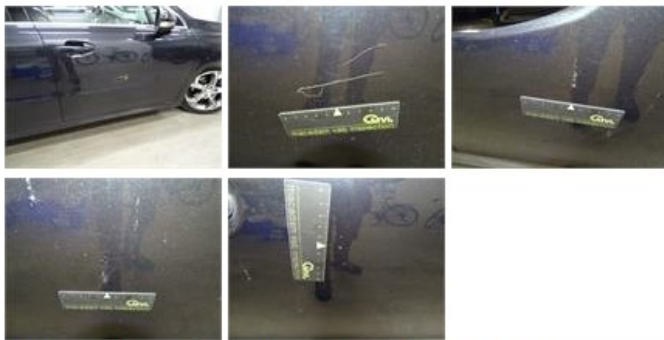
Door F R, Scratch(es), LI - Repair and paint (complete)
