VOLKSWAGEN GOLF: 1HCZ524

Limited Technical Inspection

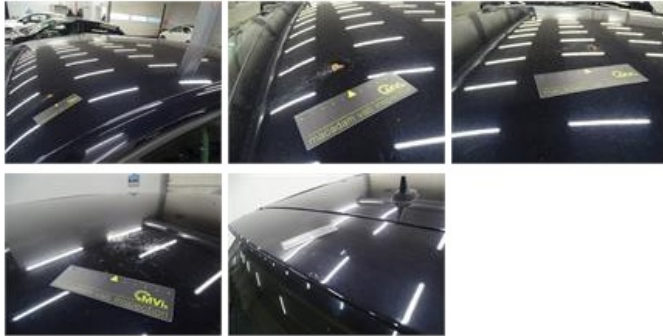
Roof, Dent(s) and scratch(es), LI - Repair and paint (complete)

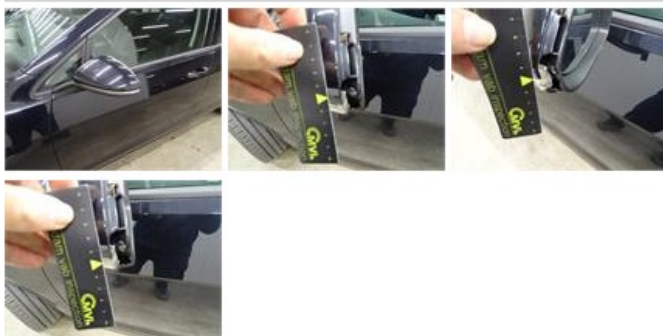
Rearview mirror L complete, Broken, Le - Replace and paint

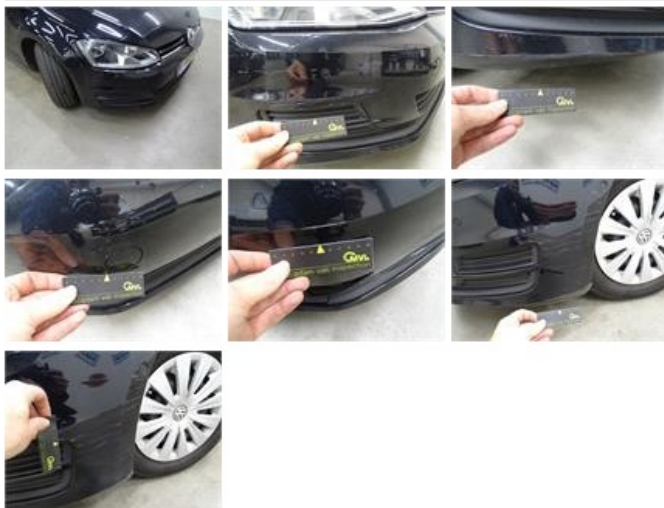
Bumper F, Scratch(es), LI - Repair and paint (complete) 211,80
