BMW 2 GRAN TOURER: 1LKC925

Limited Technical Inspection

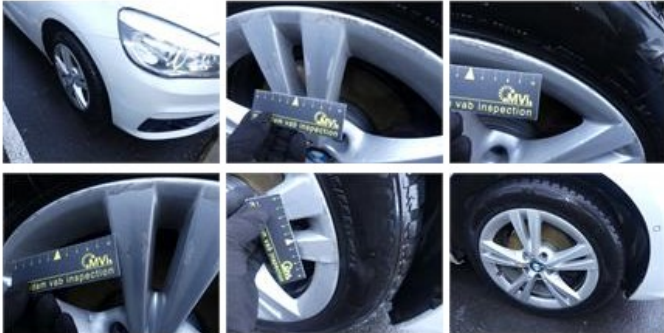
Alloy rim F R, Scratch(es), LI - Repair and paint (complete)	95,00
