**MERCEDES B: 1KAR536**

**Limited Technical Inspection**

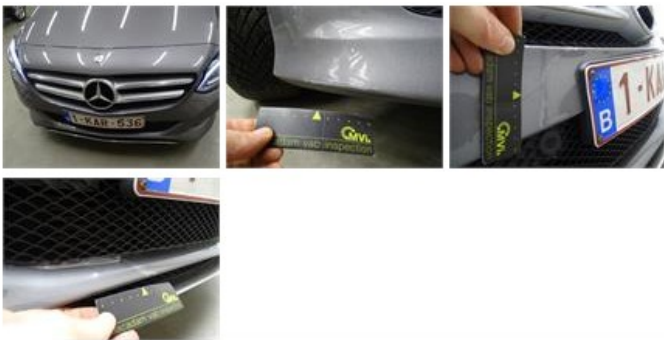
Total cost ex VAT	990,89
Door R R, Scratch(es), Acceptable	0,00
<i>No pictures to display</i>	
Bumper F, Scratch(es), LI - Repair and paint (complete)	211,80
