VOLVO V60: 1NCY558

Limited Technical Inspection

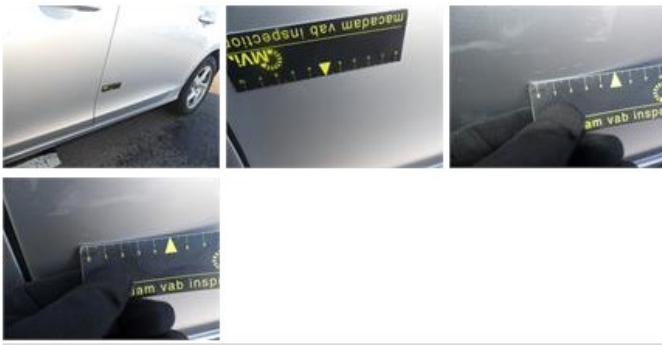
Repair kit	Yes	Compressor	Yes
Total cost ex VAT			528,91
Alloy rim R R, Scratch(es), Acceptable			0,00
<i>No pictures to display</i>			
Door R L, Scratch(es), LI - Repair and paint (complete)			0,00

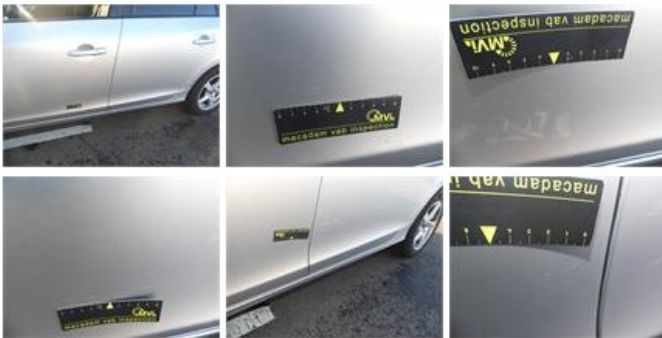
Door F L, Scratch(es), LI - Repair and paint (complete) 318,35

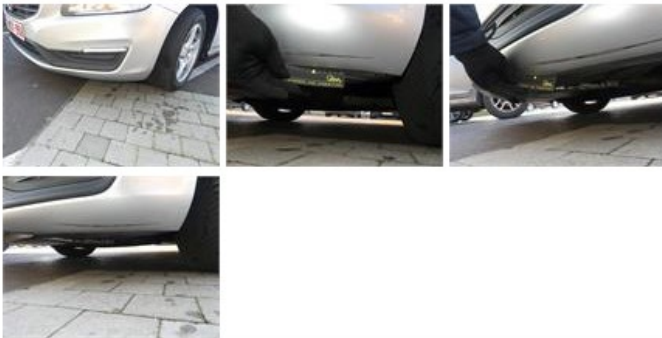
Bumper F, Scratch(es), It - Spot repair 115,56
