| BMW 3: 1GWL891 | | | |
| Vinnnumber: | WBA3D91000F406875 | Versionname: | 3 BER 316d 116PK |

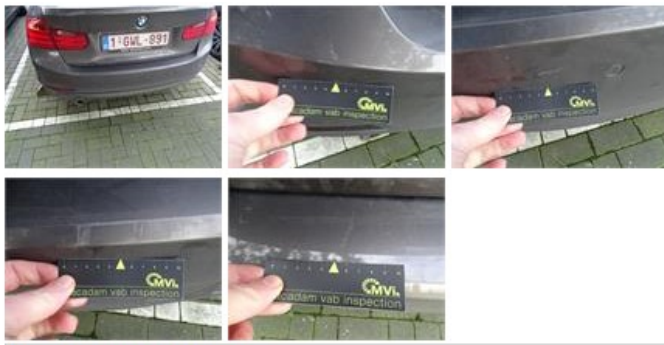
| Bumper R, Dent(s) and scratch(es), LI - Repair and paint (complete) | 211,80 |

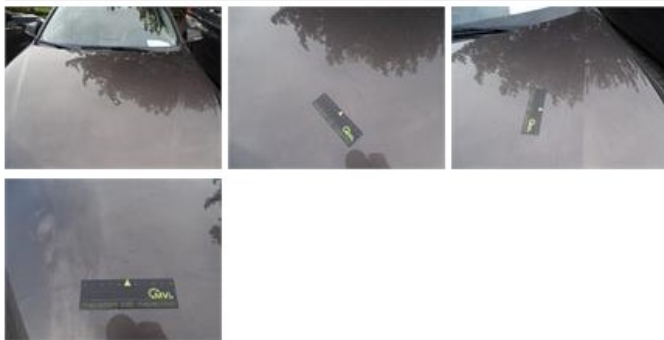
Bonnet, Scratch(es), LI - Repair and paint (complete) 290,08

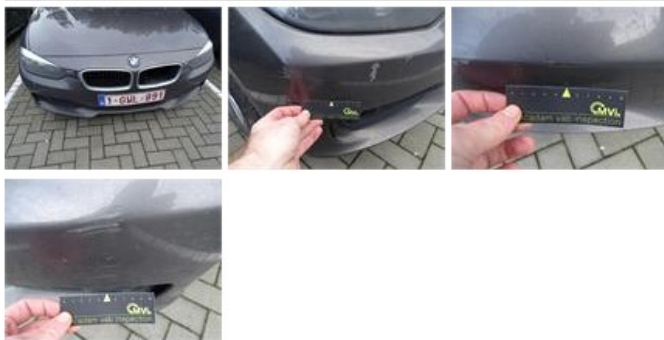
Bumper F, Scratch(es), LI - Repair and paint (complete) 211,80
