**BMW 2 ACTIVE TOURER: 1LRF096**

**Limited Technical Inspection**

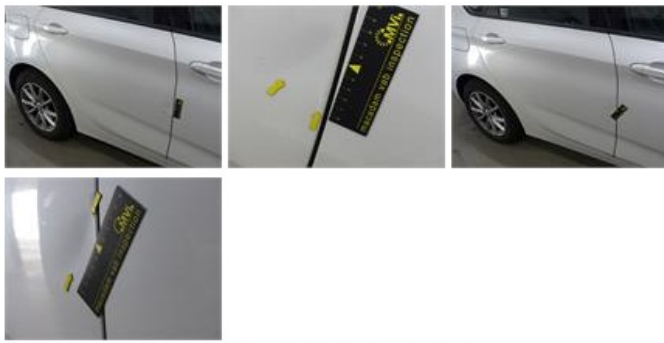
Total cost ex VAT	<b>1539,50</b>
Door R R, Bad repair, LI - Repair and paint (complete)	<b>366,35</b>

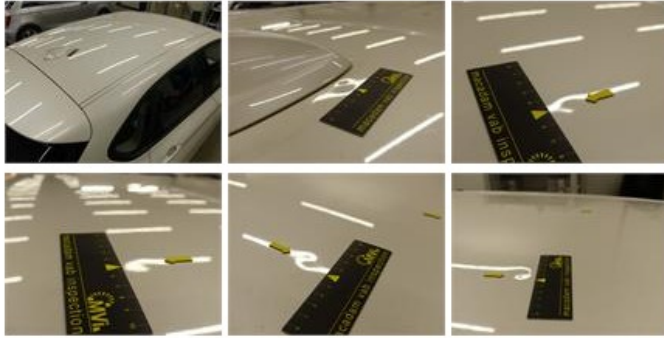
Roof, Dent(s), PDR - Paintless dent repair 241,20

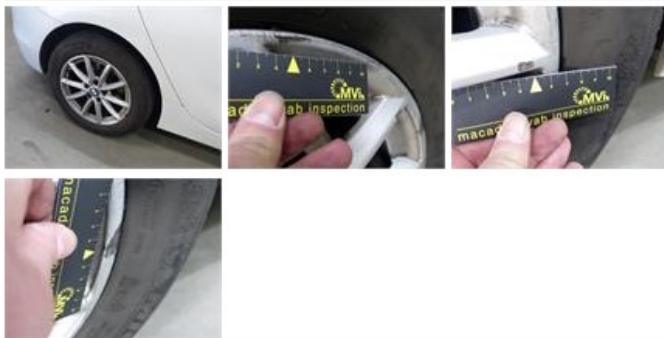
Alloy rim R R, Scratch(es), LI - Repair and paint (complete) 95,00

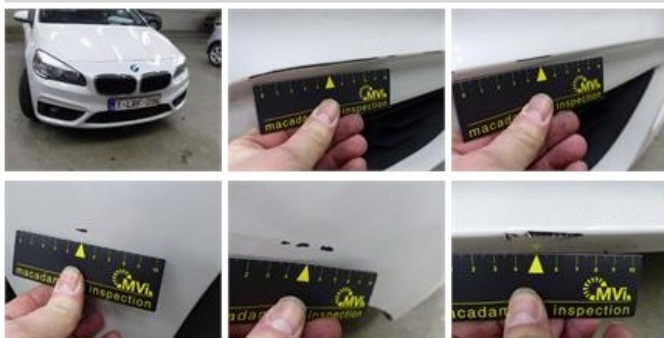
Bumper F, Scratch(es), LI - Repair and paint (complete) 211,80
