**BMW 3: 1HLC602**

**Limited Technical Inspection**

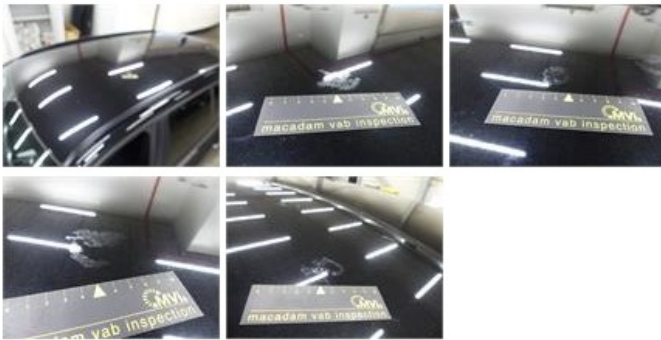
Roof, Chemical pollution, LI - Repair and paint (complete) 481,50

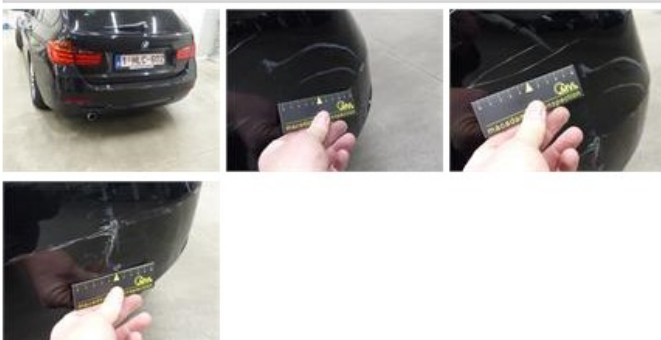
Bumper R, Scratch(es), LI - Repair and paint (complete) 211,80
