**BMW 3 TOURING: 1JNP101**

**Limited Technical Inspection**

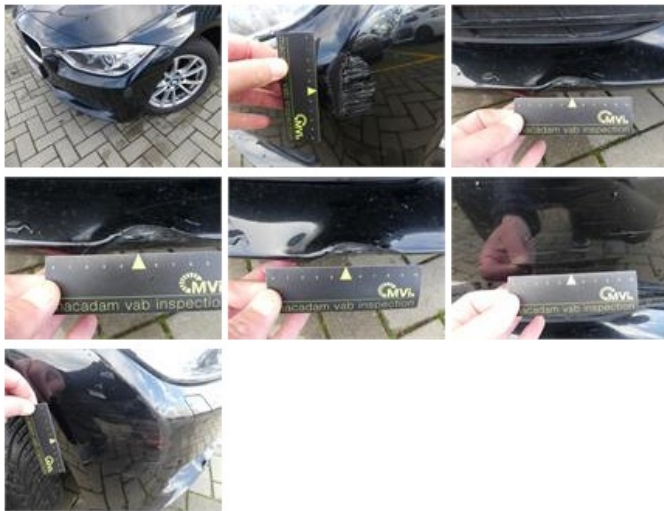
Bumper F, Crack, Le - Replace and paint 735,00

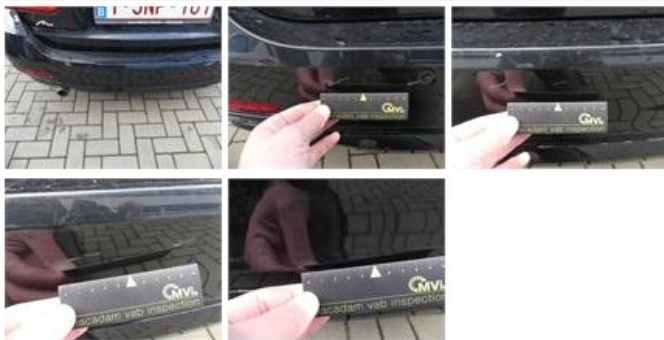
Bumper R, Scratch(es), LI - Repair and paint (complete) 211,80
