**BMW 5: 1EBQ373**

**Limited Technical Inspection**

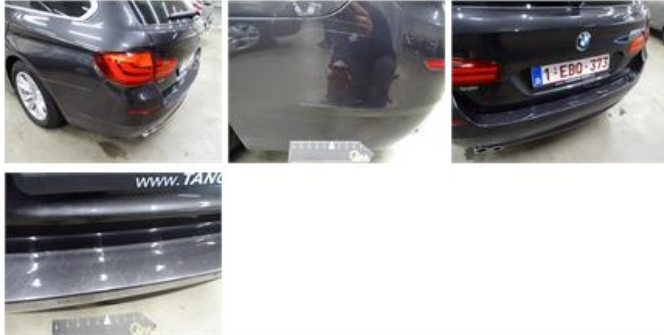
Bumper R, Scratch(es), LI - Repair and paint (complete) 254,16

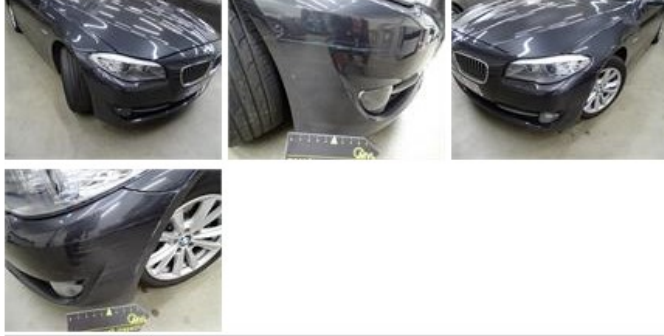
Bumper F, Scratch(es), LI - Repair and paint (complete) 254,16
