LAND ROVER RANGE ROVER EVOQUE: NG6068

Limited Technical Inspection

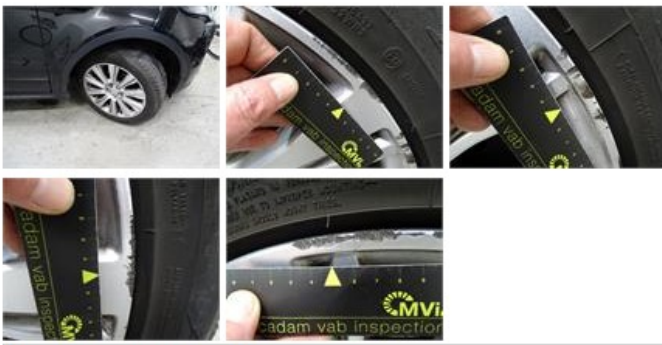
Total cost ex VAT	300,64
Alloy rim F R, Scratch(es), LI - Repair and paint (complete)	95,00

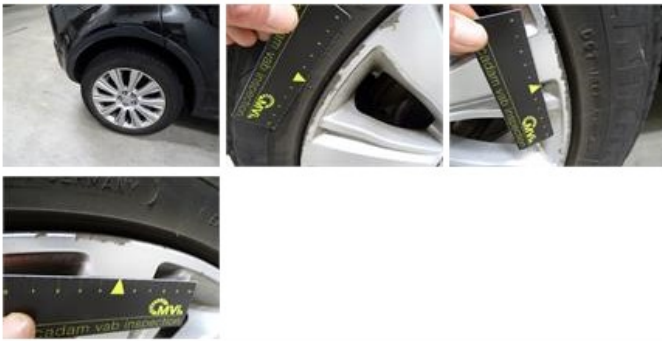
Door R R, Scratch(es), Acceptable	0,00
<i>No pictures to display</i>	
Wing R L, Scratch(es), Acceptable	0,00
<i>No pictures to display</i>	
Sill trim L, Scratch(es), Acceptable	0,00
<i>No pictures to display</i>	
Alloy rim R R, Scratch(es), LI - Repair and paint (complete)	95,00
