**HYUNDAI TUCSON: 1NPE769**

**Limited Technical Inspection**

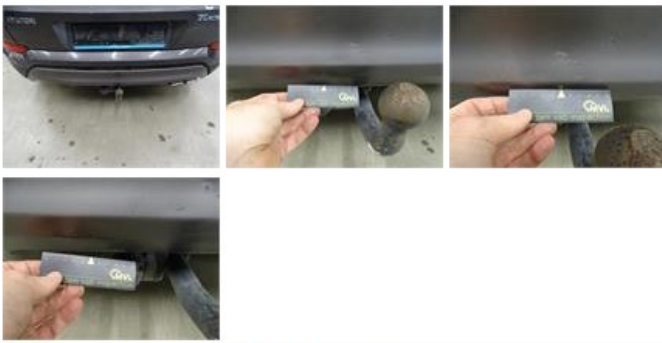
<b>Total cost ex VAT</b>	<b>2205,47</b>
<b>Bumper R, Scratch(es), It - Spot repair</b>	<b>115,56</b>

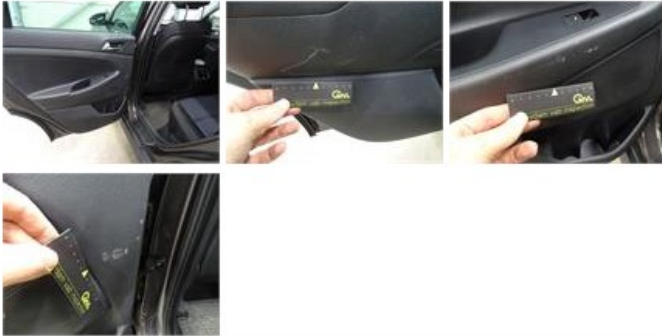
Door panel R L, Scratch(es), E - Replace 132,00
