MERCEDES A: 1KVT467

| Vinnumber: | WDD1760121V092194 | Versionname: | 1.5 A 180 CDI |

Limited Technical Inspection

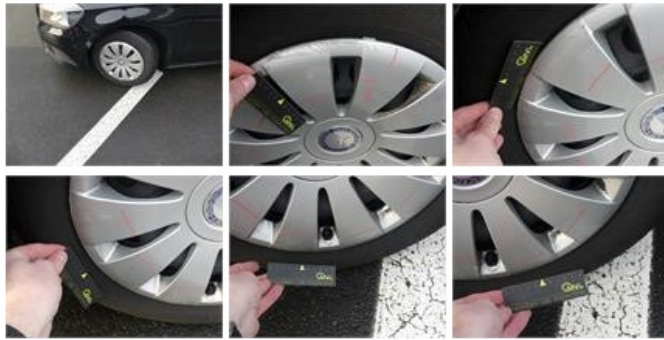
Wheel cover F L, Scratch(es), E - Replace 30,00

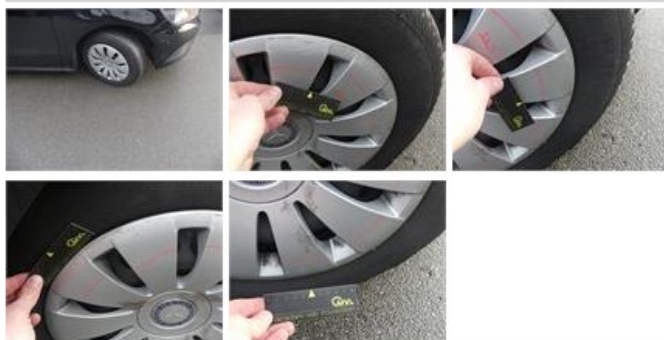
Wheel cover F R, Scratch(es), E - Replace 30,00

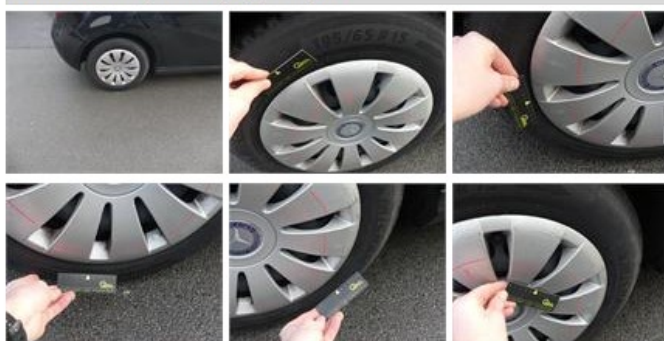
Wheel cover R R, Scratch(es), E - Replace 30,00

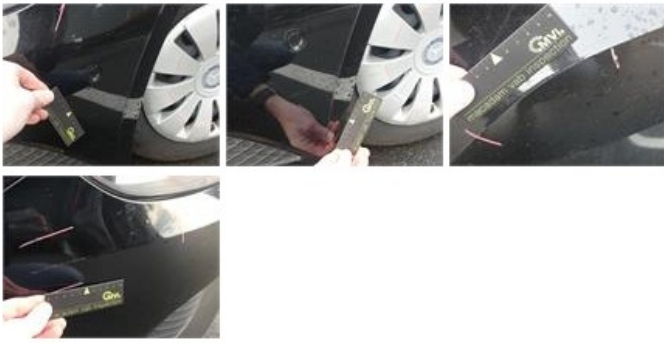
Bumper F, Scratch(es), LI - Repair and paint (complete) 211,80
