RENAULT CLIO: 1LUV873

Limited Technical Inspection

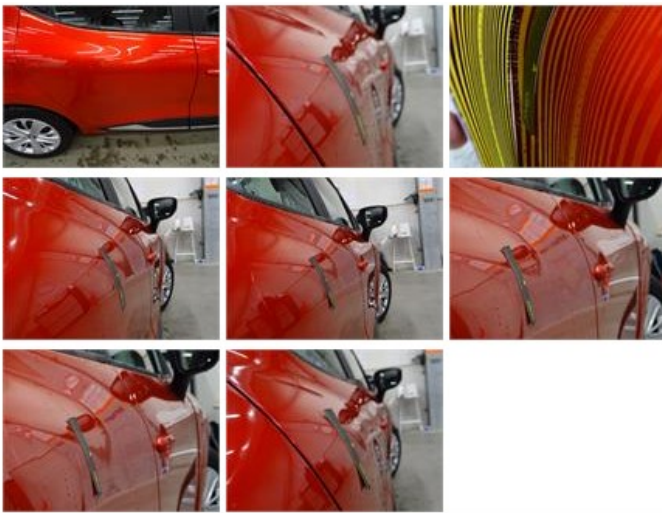
Total cost ex VAT	2320,87
Bumper F, Dent(s) and scratch(es), Acceptable	0,00
<i>No pictures to display</i>	
Door R R, Dent(s), PDR - Paintless dent repair	82,80

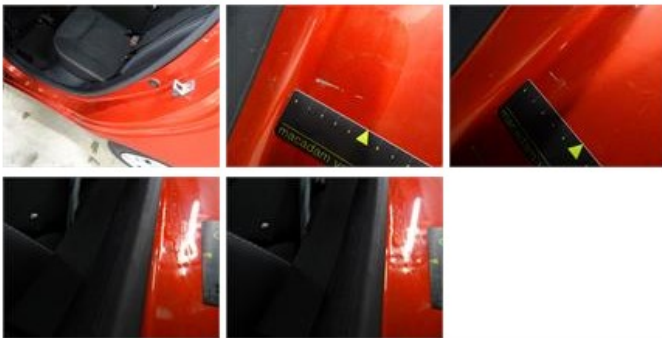
Rocker panel inner R L, Dent(s), LI - Repair and paint (complete) 115,56

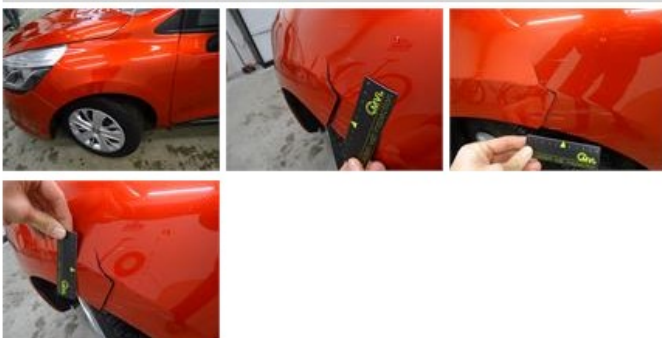
Wing F L, Crack, Le - Replace and paint 448,01

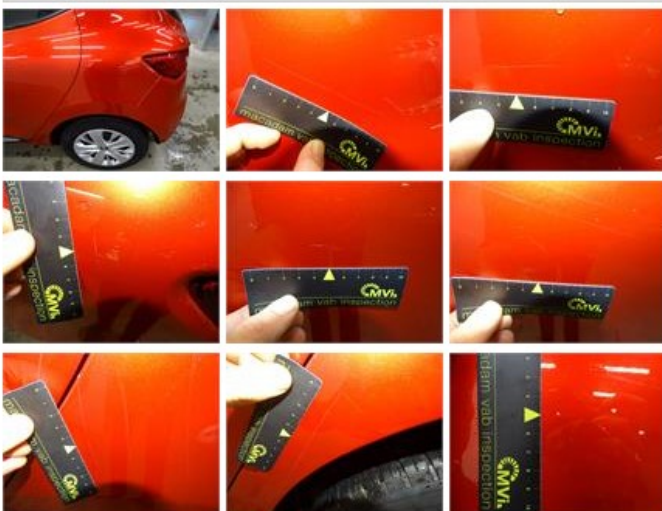
Wing R L, Scratch(es), LI - Repair and paint (complete) 246,56

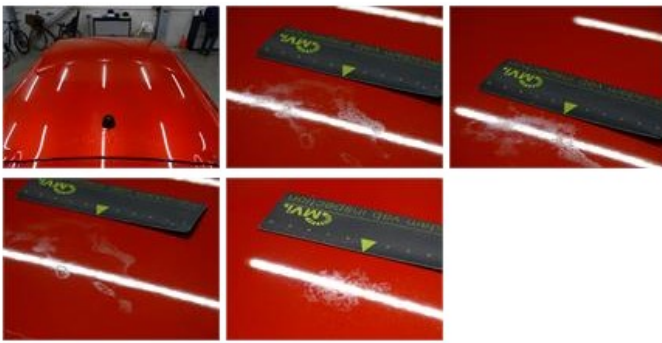
Roof, Chemical pollution, LI - Repair and paint (complete) 385,20

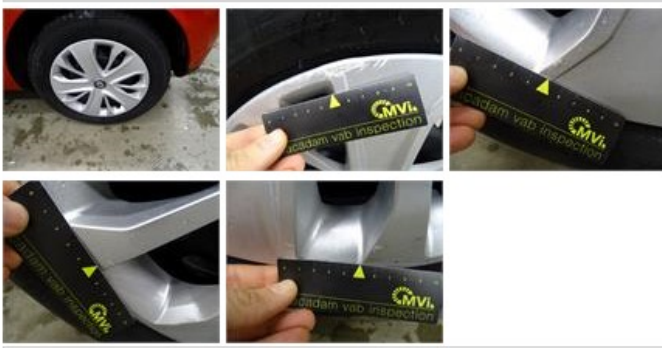
Wheel cover R L, Scratch(es), E - Replace 24,00

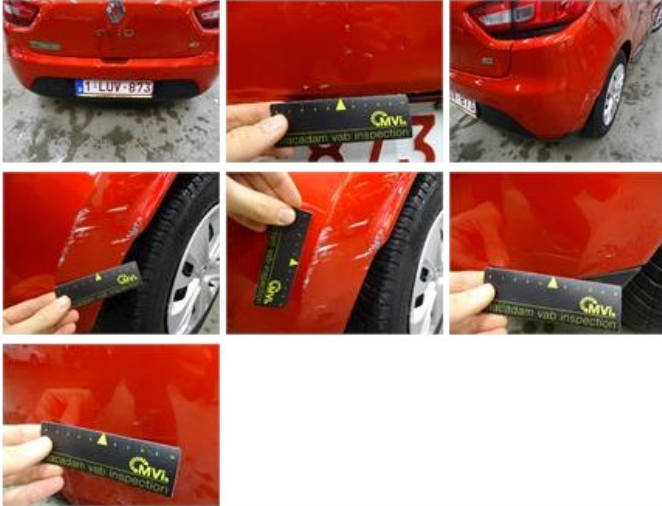
Bumper R, Scratch(es), LI - Repair and paint (complete) 169,44

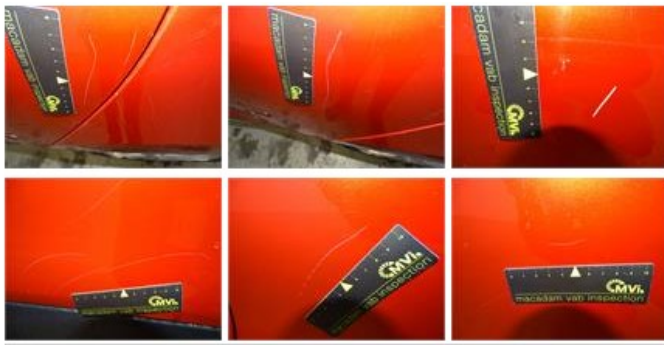
Door R L, Dent(s) and scratch(es), LI - Repair and paint (complete) 254,68

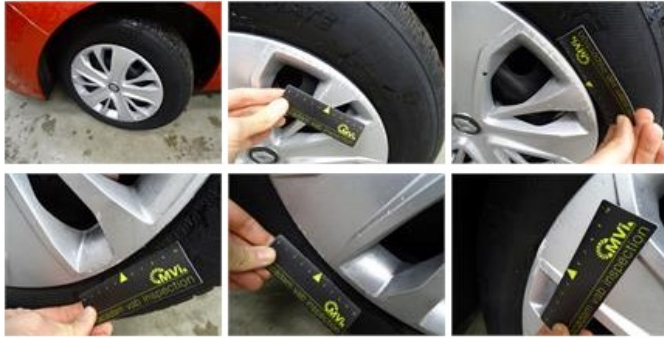
Wheel cover F L, Scratch(es), E - Replace

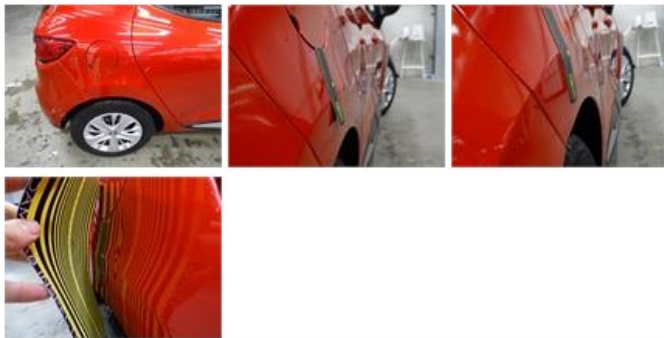
Wing R R, Dent(s), LI - Repair and paint (complete)

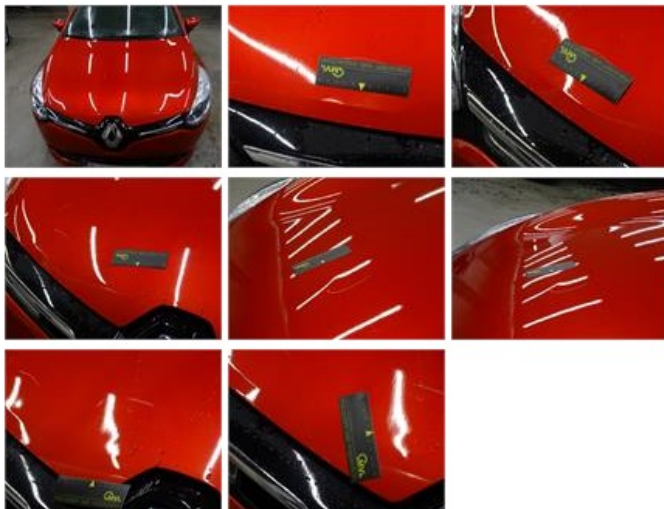
Bonnet, Deformed / Strained, LI - Repair and paint (complete)

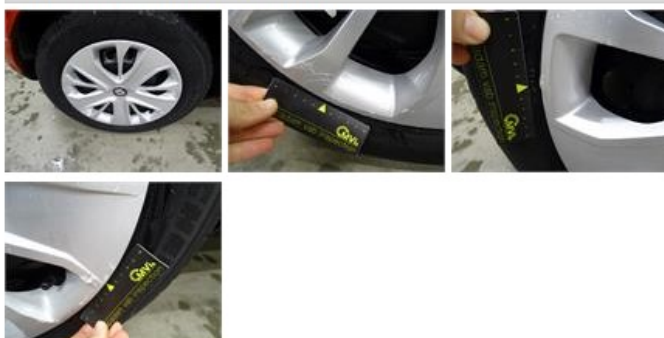
Wheel cover R R, Scratch(es), E - Replace
