## TOYOTA VERSO: 1LEN581

| Vinnumber: | NMTDM26R70R030955 | Versionname: | 1.6 D-4D SKYVIEW 7PL |

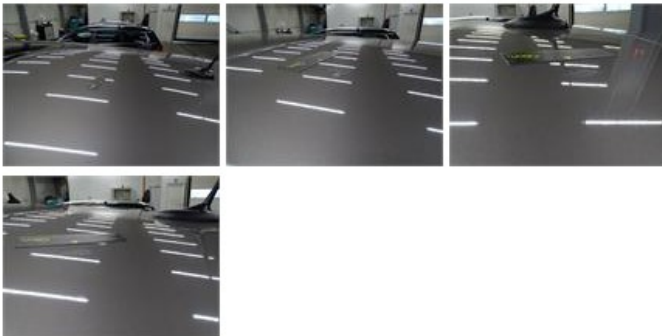
| Roof, Chemical polution, LI - Repair and paint (complete) | 481,50 |

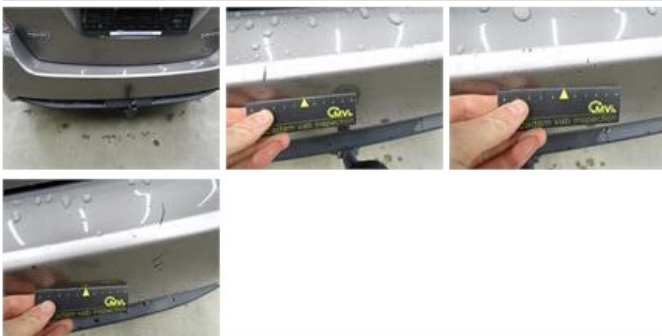
| Bumper R, Scratch(es), LI - Repair and paint (complete) | 211,80 |
