VOLKSWAGEN TOURAN: 1LSN517

| Vinnnumber: | WVGZZZ1TZGW514960 | Versionname: | 1.6 TDI SCR 81KW BMT TRENDLINE |

Limited Technical Inspection

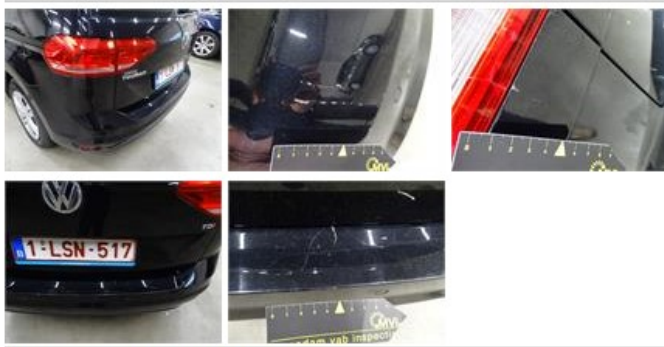
Bumper R, Scratch(es), LI - Repair and paint (complete) 211,80

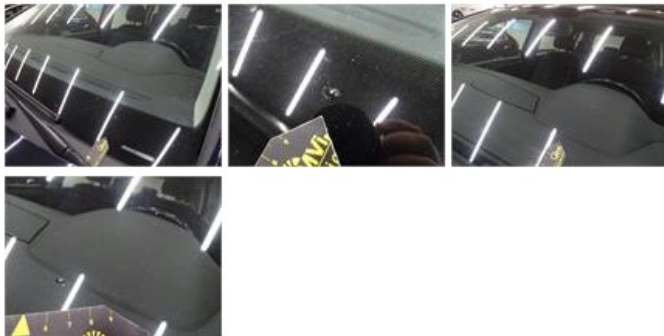
Windscreen, Stone chip(s), E - Replace 487,20
