SKODA Superb: 1JFU765

Limited Technical Inspection

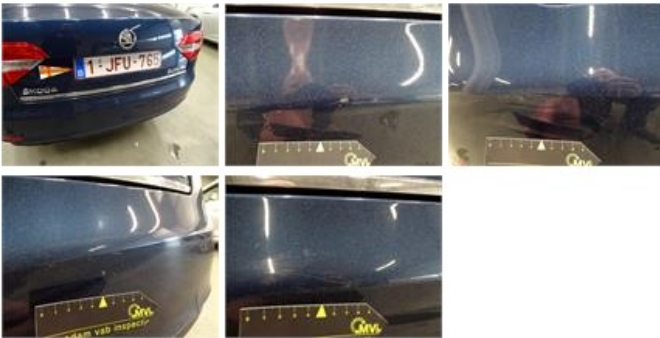
Bumper R, Scratch(es), LI - Repair and paint (complete)

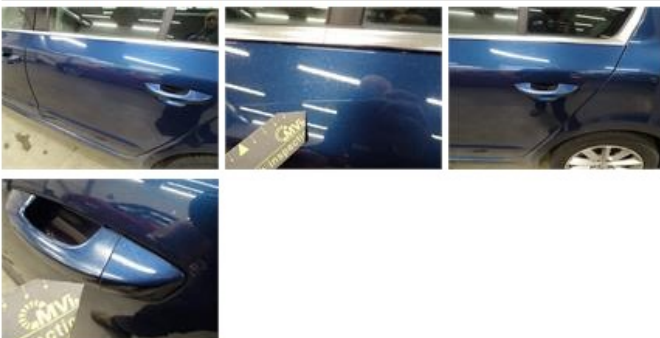
Door R L, Bad repair, LI - Repair and paint (complete)

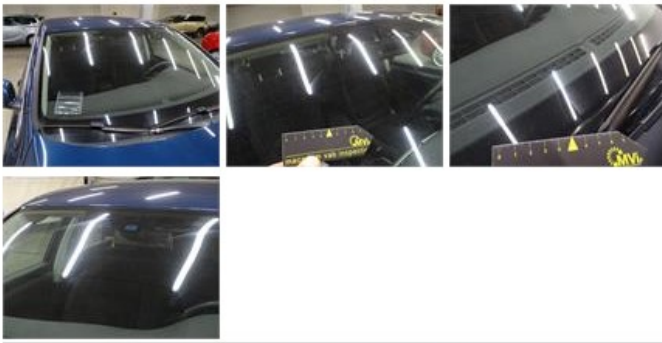
Windscreen, Scratch(es), E - Replace
