HONDA JAZZ: 1CNZ924			
Vinnumber:	LUCGG275093214174	Versionname:	
First Registrationdate:	4/11/2009	Fiscalpower:	
Expertise Mileage:	276507	Power Kw:	66
Bodytype:		Body color:	Red
Gearbox:	MAN 5 VIT	Paint type:	Metalic
Transmission:	Front	Rims summer:	Aluminium
Fueltype:	Petrol	Oil level:	OK
Battery functioning:	Yes	Parking lot:	3614
Number of doors:	5		
Number of seats:	5		
Number head rests:	5		
Rims summer:	Aluminium		
Category:	Passenger Car		
Oil level:	OK

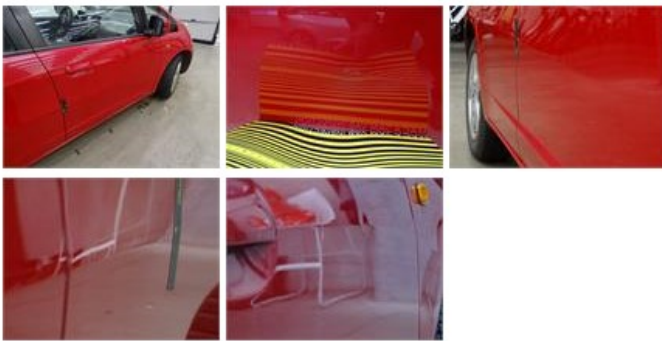
Door F R, Dent(s), LI - Repair and paint (complete) 302,68

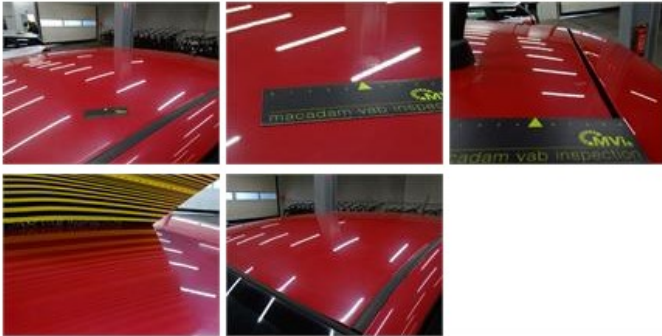
Roof, Chemical pollution, LI - Repair and paint (complete) 529,20

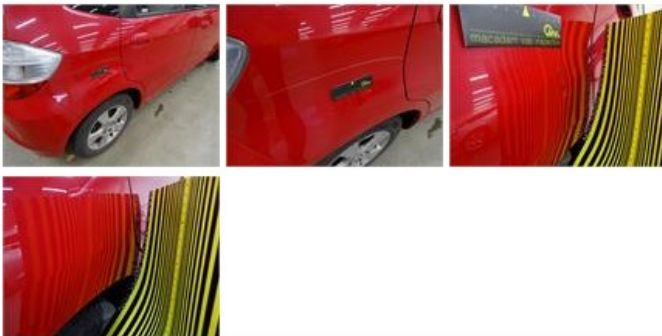
Wing R R, Dent(s) and scratch(es), LI - Repair and paint (complete) 342,56
