**BMW 3 GRAN TURISMO: 1LTL551**

**Limited Technical Inspection**

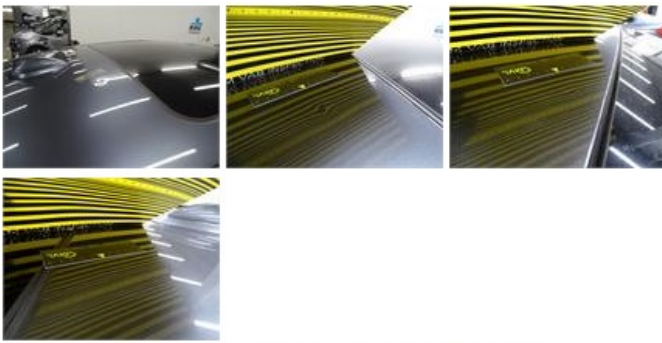
<b>Roof, Dent(s), PDR - Paintless dent repair</b>	<b>102,60</b>
---	---------------
