SKODA Octavia: 1FAK474

Limited Technical Inspection

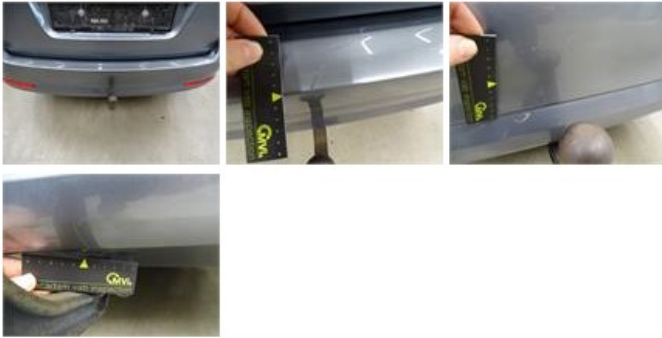
Bumper R, Scratch(es), LI - Repair and paint (complete) 211,80
