MERCEDES A: 1JAB195

Limited Technical Inspection

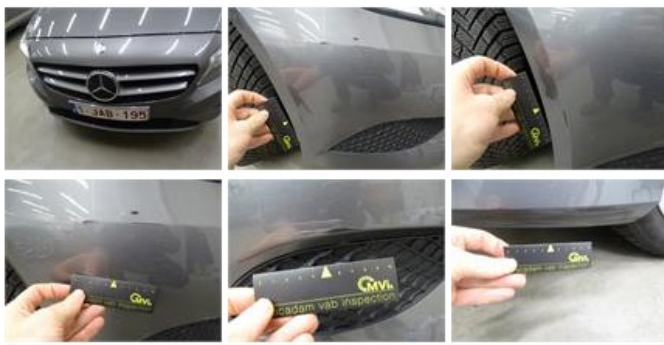
Total cost ex VAT	1350,79
Bumper F, Scratch(es), LI - Repair and paint (complete)	211,80

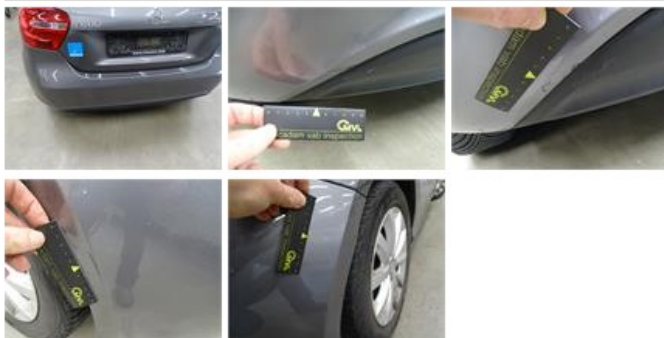
Bumper R, Scratch(es), LI - Repair and paint (complete)

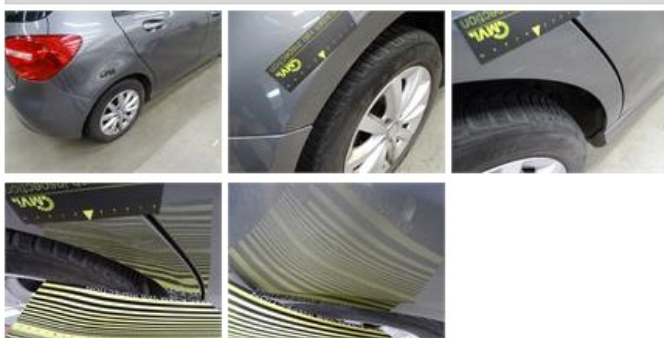
Wing R R, Dent(s) and scratch(es), LI - Repair and paint (complete)
