**MERCEDES Vito: 1ETE154**

**Limited Technical Inspection**

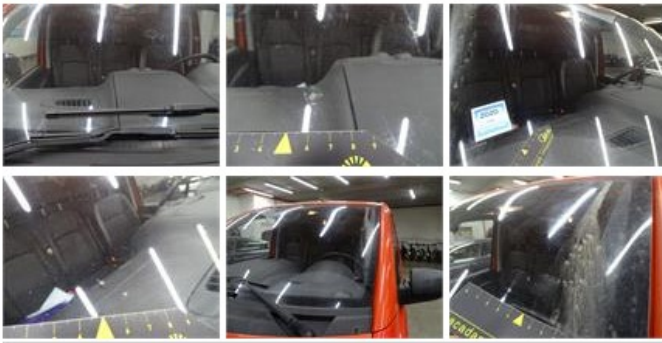
Windscreen, Repaired, Acceptable	0,00
----------------------------------	------
