SKODA Octavia: 1HFL604

Limited Technical Inspection

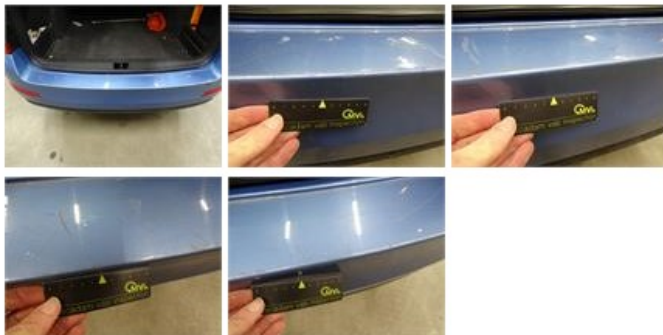
Bumper R, Scratch(es), LI - Repair and paint (complete)
