**LU Volkswagen Golf: VK7637**

**Limited Technical Inspection**

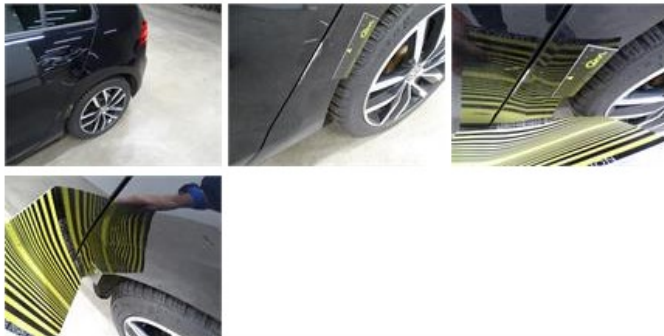
Wing R L, Dent(s) and scratch(es), LI - Repair and paint (complete)

308,20
