VOLVO V60: 1JSJ556

Limited Technical Inspection

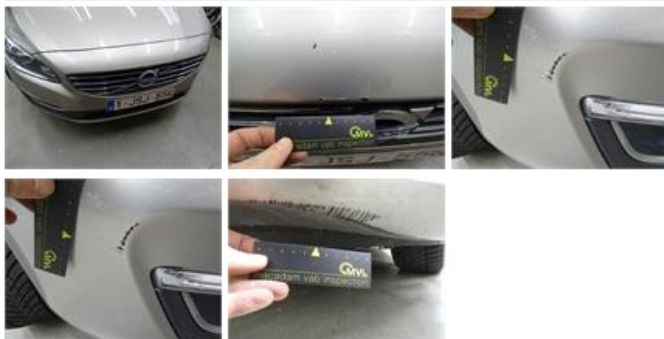
Bumper F, Scratch(es), LI - Repair and paint (complete)

211,80
