**TOYOTA AURIS: 1PNC022**

**Limited Technical Inspection**

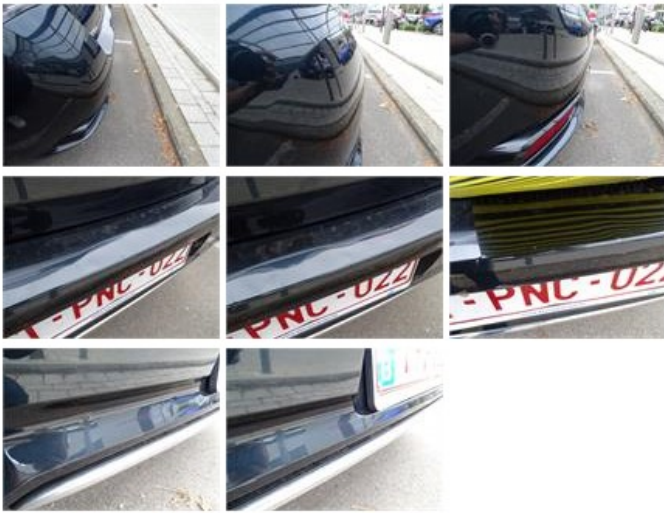
Repair kit	<b>Yes</b>	Compressor	<b>Yes</b>
Total cost ex VAT			<b>731,56</b>
Bumper R, Dent(s) and scratch(es), LI - Repair and paint (complete)			<b>307,80</b>
