**BMW 3 BERLINE: 1KAB634**

**Limited Technical Inspection**

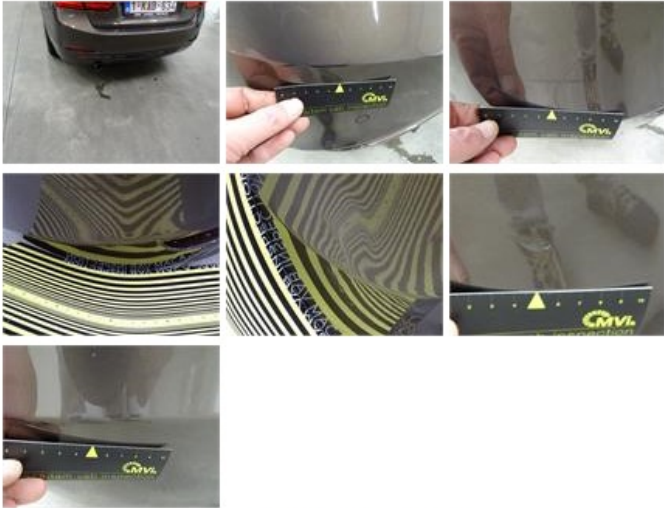
Bumper R, Dent(s) and scratch(es), LI - Repair and paint (complete) 211,80

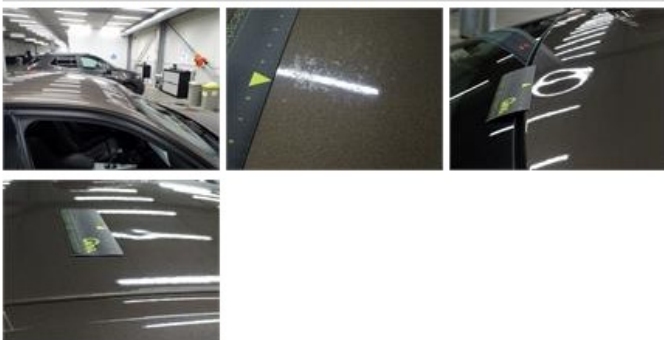
Roof, Chemical polution, LI - Repair and paint (complete) 481,50
