**HYUNDAI I40 WAGON: 1KHJ972**

**Limited Technical Inspection**

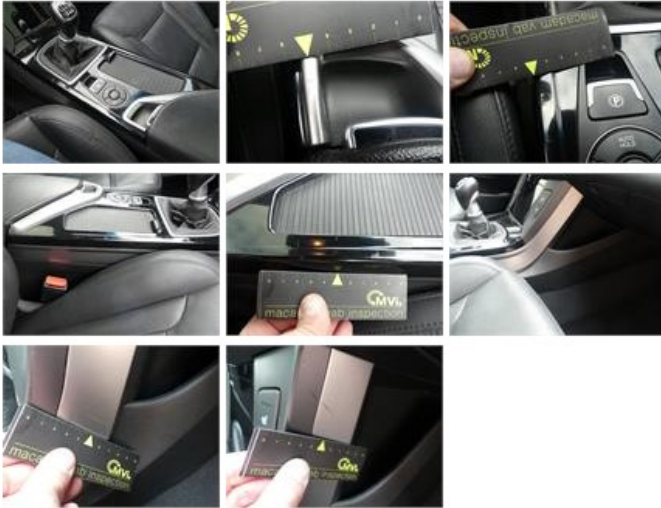
Centre console, Scratch(es), Smart repair 110,64
