VOLKSWAGEN CC: 1JSE606

Limited Technical Inspection

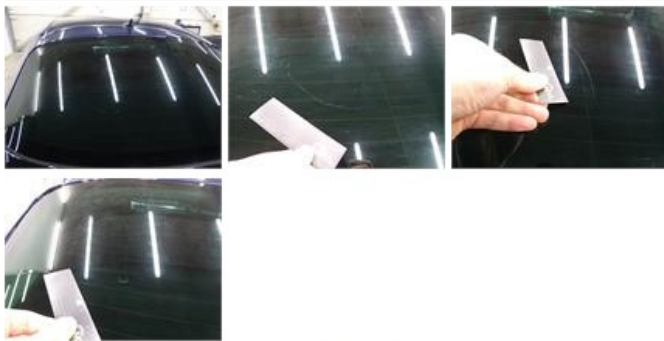
Rear window, Scratch(es), E - Replace 0,00
