**BMW 5 TOURING: 1LCE769**

**Limited Technical Inspection**

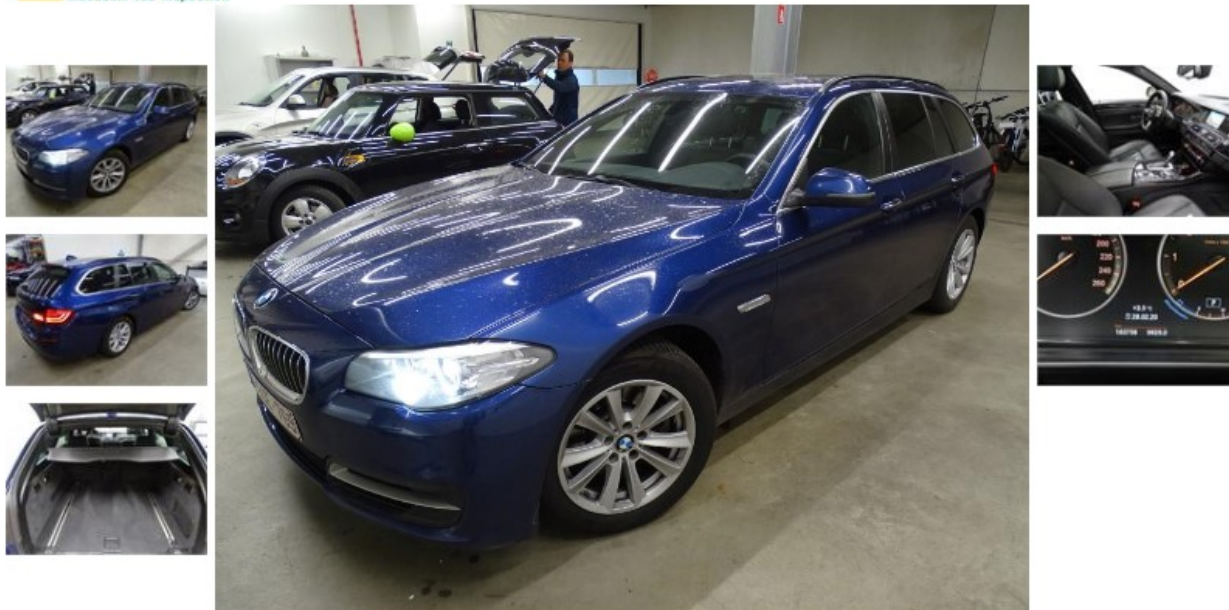
<b>Total cost ex VAT</b>	<b>624,00</b>
<b>Bumper F, Scratch(es), LI - Repair and paint (complete)</b>	<b>254,16</b>
